RELIABILITY IMPROVEMENT AND FAILURE REDUCTION OF COOLING TOWER FANS

Dr. Chinmaya Kar

Mr. Abdulmajeed A. Ba-Jandouh

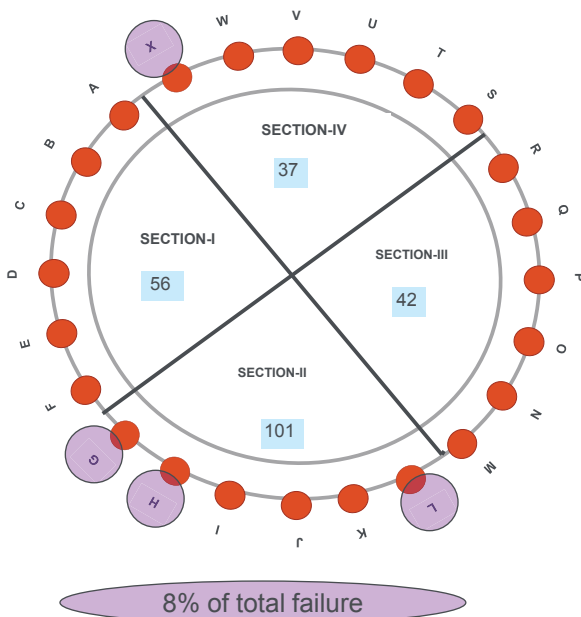
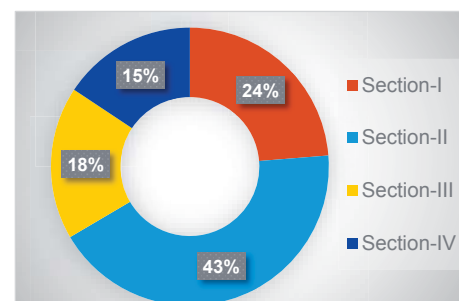
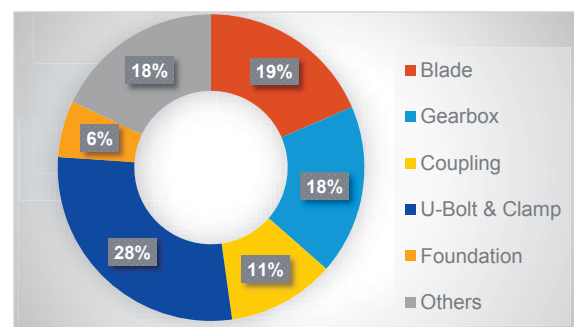
PROBLEM STATEMENT: FAILURE MODES OF FANS (TILL JUNE'13)

- **Total amount of failures in cooling tower fans has been reduced by 56%**
- **Maximum Failures are in Fan- K of Section -2 (with 10% of total failures)**
- **Failures in Sections as %age of total failures**
 - Section-1: 32%
 - Section-2: 32%
 - Section-3: 19%
 - Section-4: 17%
- Contribution of Section-2 to total number of failures have been reduced due to design modifications of its two important fans (Fan-L and Fan-H)

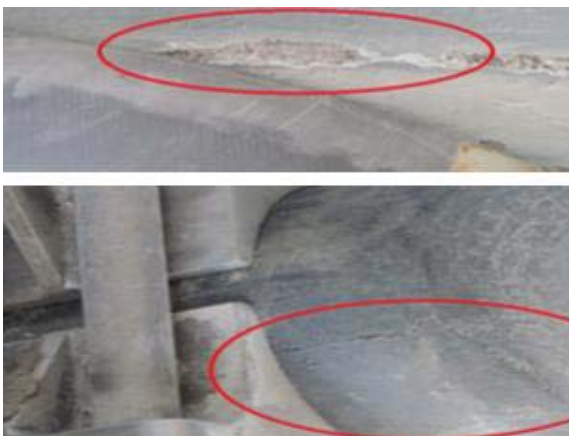
Prototype-2 Failure

- The rubbing of one blade of Fan H and the ring was found that caused large vibration
- The Fan L was found to have a broken Duplex U-bolt with crack at the threads (corrosion) and inherent defect
- However, it has less failure rate
