LESSON LEARN FROM FAILURES: FAILURE OF MIXED FEED COIL IN PRIMARY REFORMER

Nov. 2015

By: Saad Mohammed Al-Qahtani

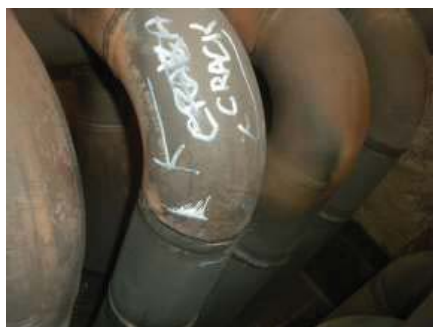
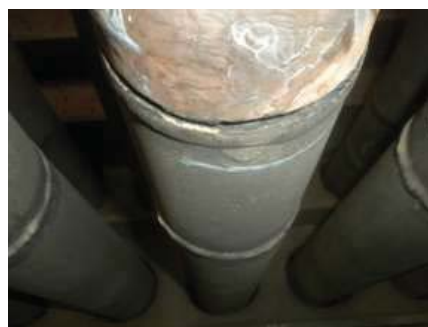
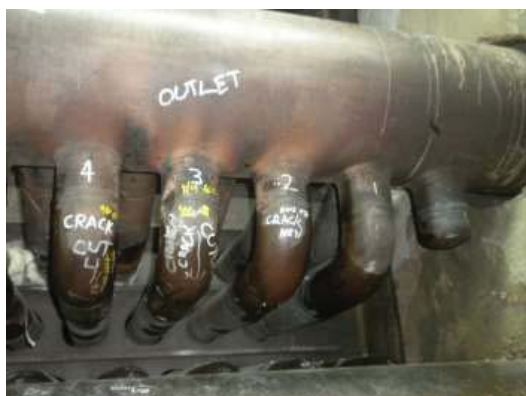
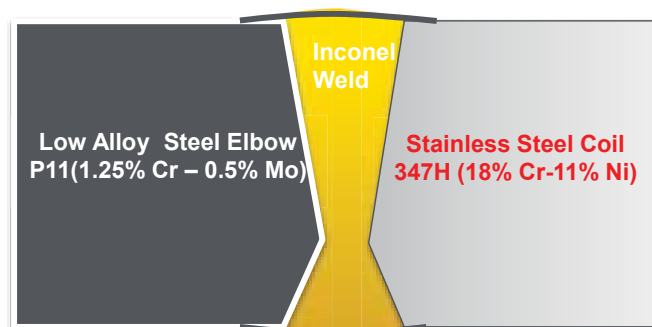
Cracked Weld

- Inspection Procedure most probably not Followed (Manufacturing Defect not identified by liquid penetrant inspection and visual inspection and not reported)
- NDT technique (RT) not fully effective (ASME V & MCE) for this type of defect geometry (lack of side wall fusion)

#	Major Findings
1	Total Seven (7) Dissimilar Metal Weld (DMW) joints were found damaged in Mix Feed Coil.
a	One DMW Joint (between P11 & 347H) on Mixed Feed Outlet Header side, found completely cracked & detached from WELD TOE at P11 side, in Visual Testing.
b	Cracks were revealed in Four DMW joints in other rows of the same coil, in Penetrant Testing.
c	One DMW joint was found cracked in the Radiography results.
d	Another DMW joint in same coil was found leaking during Hydro test when pressure reached to 8.0 BarG.
2	One DMW joint in Steam-Air coil was found having crack on Outlet Header side, during visual inspection.

Root/Contributing Cause(s)	Action Item	Responsibility	Target Date
Inspection Procedure not Followed (Manufacturing Defect not identified by Radiographic inspection and not reported)	Communicate with E&PM PMT on Inspection and Test Plan for mega projects to be reviewed for eliminating the recurrence of such deviations.	ESD	Feb 2015
NDT technique (RT) not fully effective (ASME V & MCE)	Raise ESTS to review the relevant SABIC Engineering Standards (SES)	ESD	Feb 2015
