# RUBBING DETECTION IN A SYNTHESIS GAS COMPRESSOR

NOV 2015

By: Dr. Chinmaya Kar & Mr. Waleed J. Al-Sallom

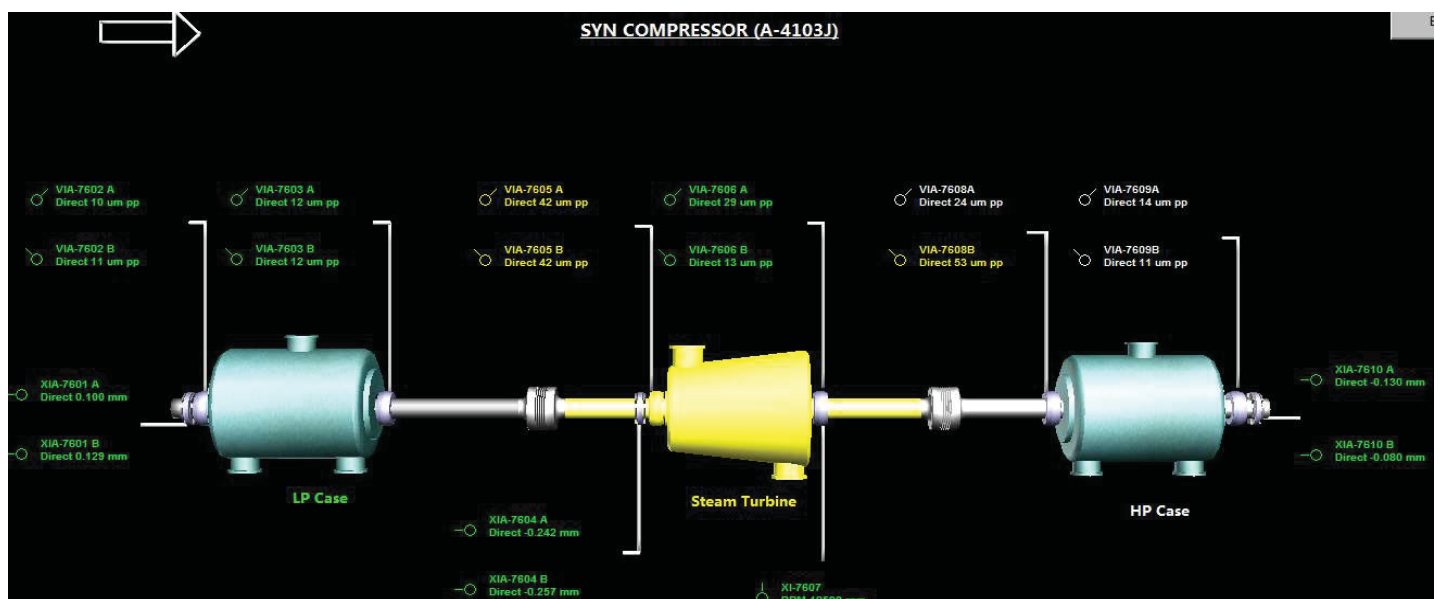
## OVERALL SHAFT VIBRATION IN MARCH 2014

- The LP side of steam turbine vibration shows a large amplitude of 42µm pp in both the direction
- One of the HP side probe of the steam turbine shows 53µm pp

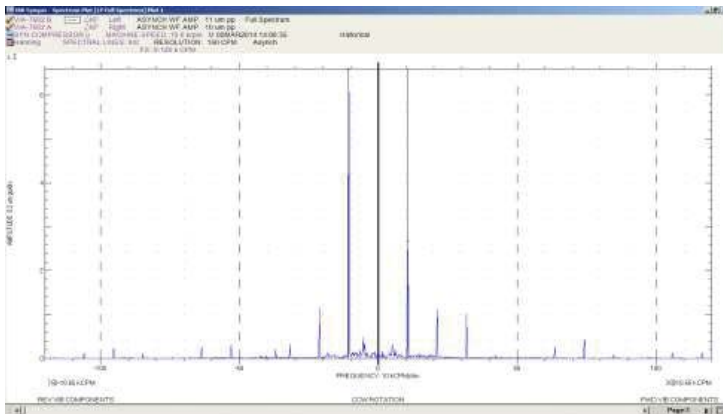
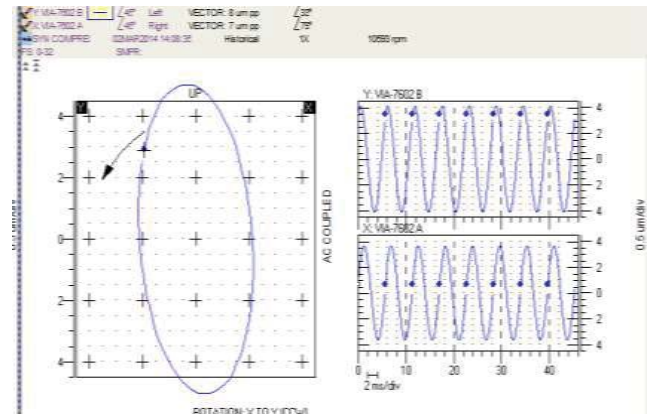
- The LP compressor's NDE probes indicate normal vibration
- There is a reverse precession observed (may be detrimental in future with large fatigue of the shaft) – this may be the reason of probe and key phasor placement as well

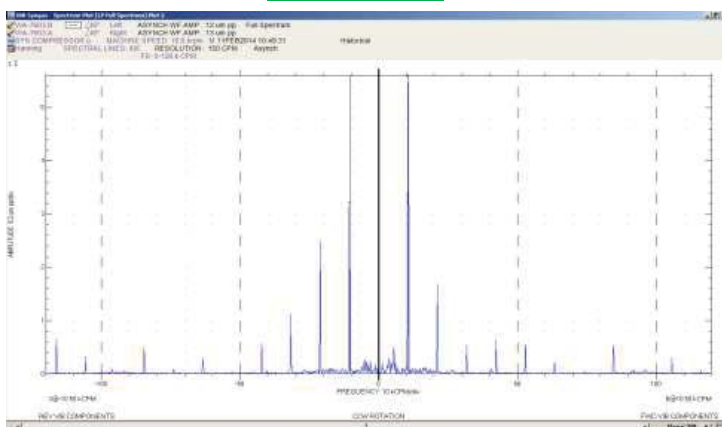
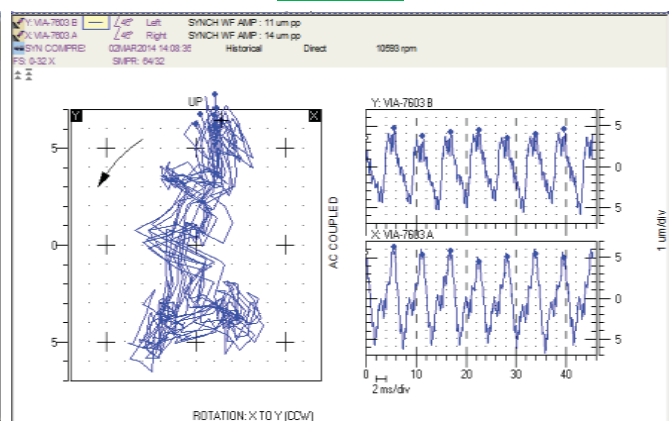
- The LP compressor's DE probes indicate normal vibration
- There are a number of 1X, 2X, 3X components shows either looseness or rubbing
  - The mild looseness / rubbing indicates that it may be in the journal / seal / coupling
- Though the orbit plot is very irregular, doesn't show rubbing (impact – with straight lines) – may be an effect of steam turbine's LP side vibration

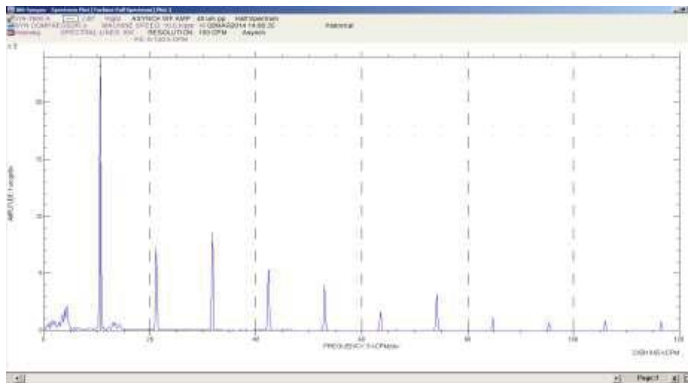
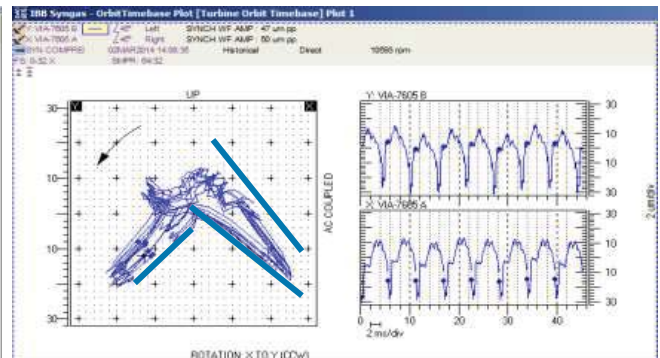
- The Steam turbine's LP Side probes indicate large vibration of 42µm pp in both the direction
- There are 1X, 2X, 3X components and also sub-harmonic component (near rotor natural frequency of 4000rpm) - either looseness or rubbing at bearing / seal / coupling
- The orbit plot is very irregular with some impact and straight lines and hence shows some mild rubbing

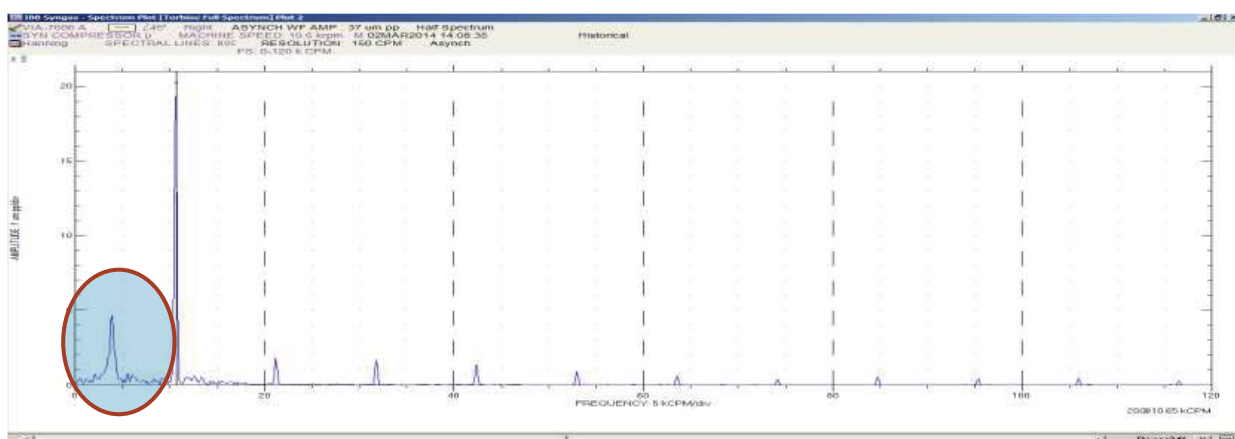
- The Steam turbine's HP Side probes indicate normal vibration
- However, large sub-harmonic components (particularly at exciting the rotor natural frequency) is a concern
  - The sub-harmonic component even showing an amplitude of 5µm which is very large

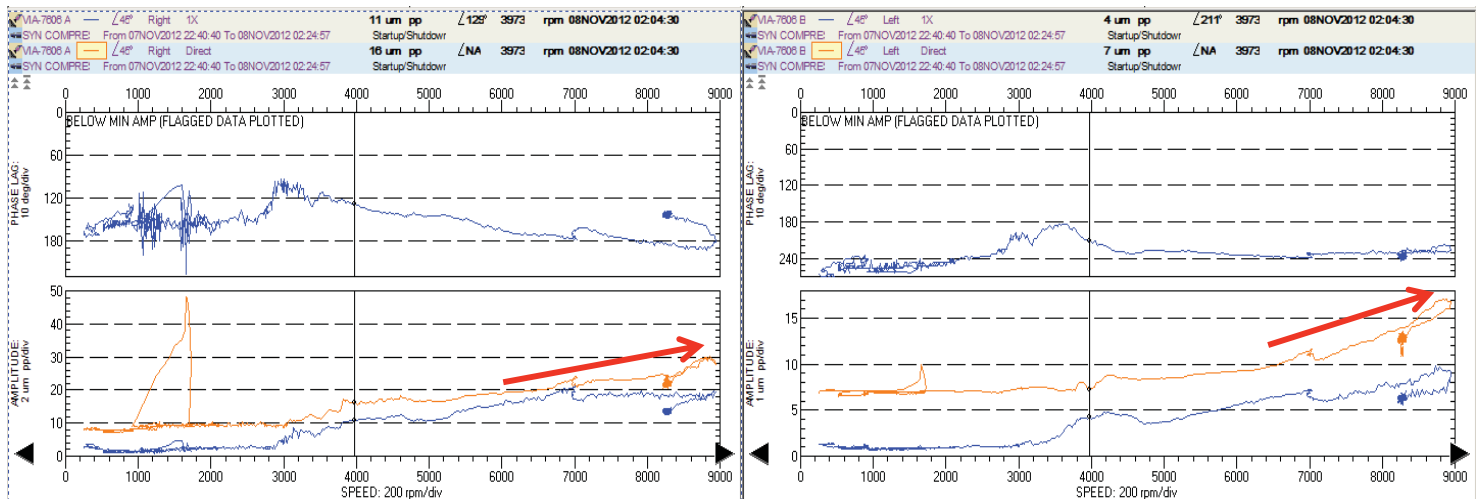
- The Bode plot reveals large unbalance only at turbine HP side end as seen in the trend below
  - The amplitude increases with speed and phase between the probes is nearly 90°
- The other Bode plot have
  - Either large amplitude for some RPM range and then decreases with speed
  - Or have less amplitude

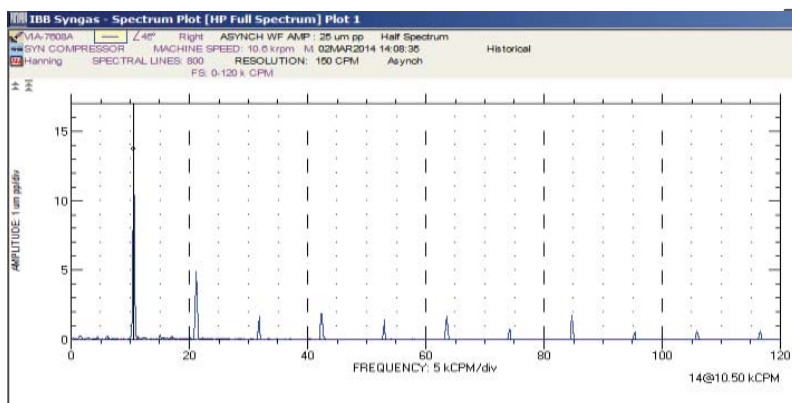
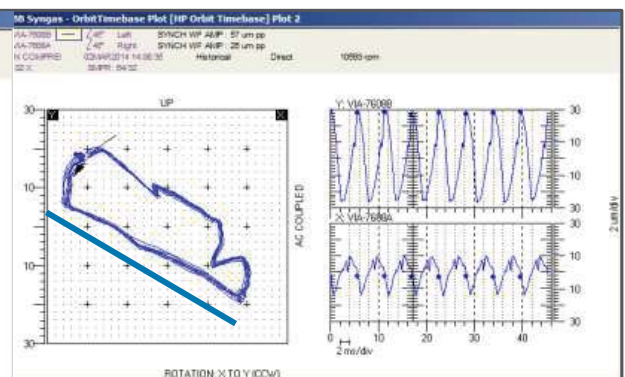
- The HP Compressor's DE Side probes indicate large vibration of 53μm pp in one direction (7608B)
- There are a number of 1X, 2X, 3X components shows either looseness or rubbing
- The orbit plot is very irregular with some impact and straight lines and hence shows some mild rubbing

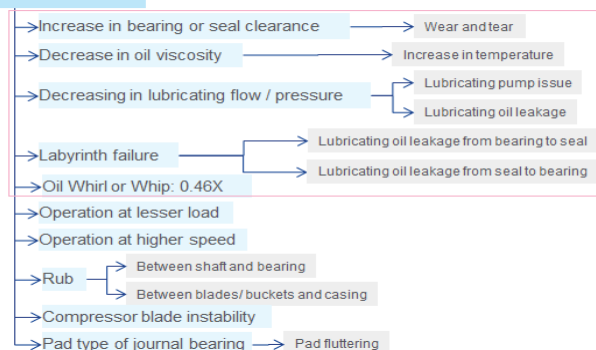
### Subsynchronous Vibration

The sub-synchronous vibration with signs of rubbing may also be the effect of

- Either rubbing at the seal
- Or rubbing at the gear coupling
