## **Helium Leak Detection in High Pressure Urea Reactor**

**ALI AL SIYABI & ANKIT NIRANJAN**  
**OMAN INDIA FERTILIZER COMPANY**  
OMAN

*Oman India Fertilizer Company was commissioned in April – 2005. The performance in the first ten commercial years of operation has been very good and the entire envisaged project target has been accomplished. This paper discusses high pressure reactor liner leakage issue in Urea-I unit. Leakage location could not be traced by conventional methods until OMIFCO strove for helium leak detection.*

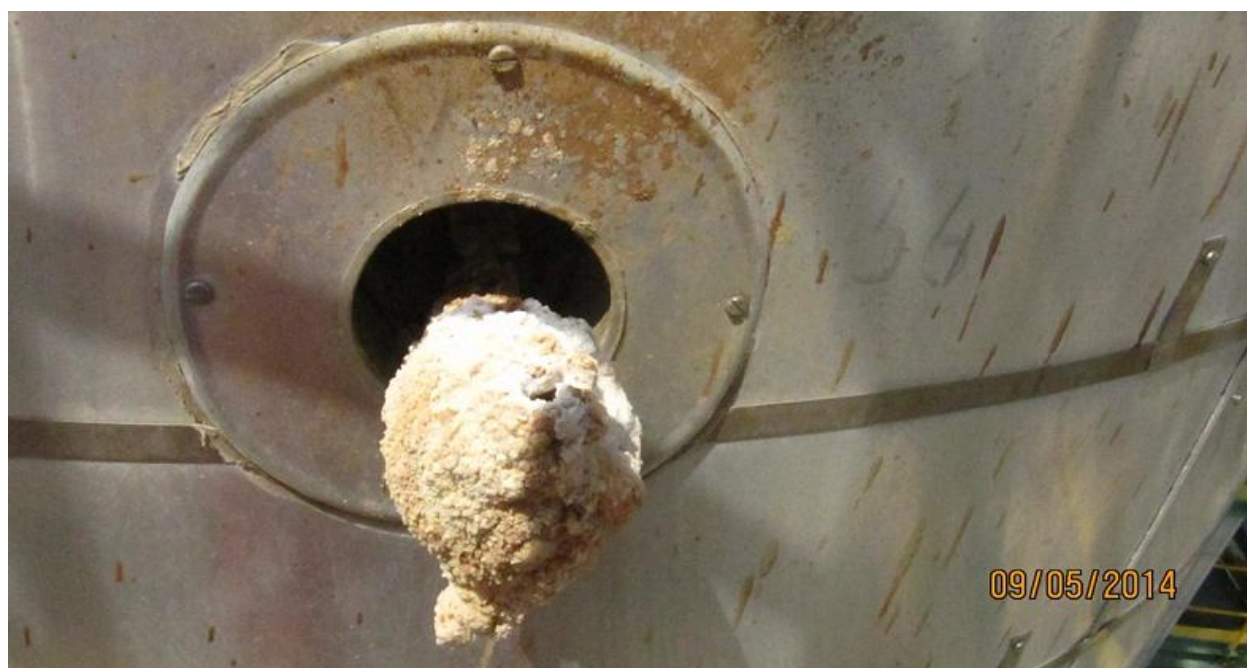
**Fig. 3: (Leakage through Weephole)**

In Urea-11 unit during the plant shutdown inspection on 9<sup>th</sup> May 2014, a crystallized urea product is observed at the end of weep hole No.-56. This was the clear sign of leakage of the liner in progress during the operation of the plant. Also the same is confirmed by the lab reports. It was decided to ascertain the leakage location. No indication noticed on C-seam, L-seam & cleat joints by visual inspection & D.P. Testing corresponding to weep holes. (#55, 56, 23 & 24)

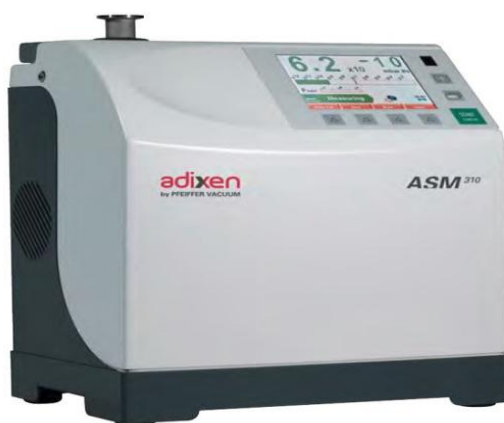
Figs. 4&Fig 05: (Testing Machine)

### Pressure Testing (Inside-out/Sniffer method)

In Pressure Testing, the part is pressurized with helium or a mixture of helium and air. To Locate a Leak, the potential leak sites of the part are scanned using a Sniffer Probe connected to the inlet of the leak detector.

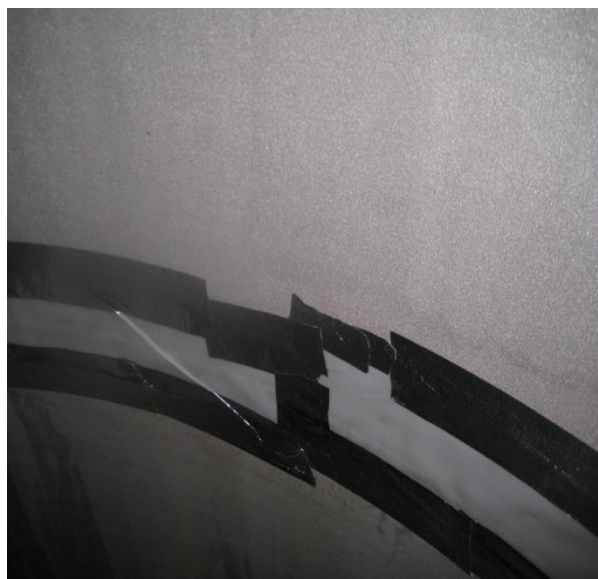
Figs 7 & 8: (Test in Progress) & (Polythene sheet masked by sheet)

The annular space between inner lining and shell is pressurized with helium gas. Pressure is maintained around 0.5 Kg/Cm<sup>2</sup> g. Since gas/air is already present in the annular space, concentration of helium gas reduces in the annular space. Four hour holding time was given. Presence of any helium under polythene sheet was checked by inserting tip of detector probe. Leakage is identified by Helium test in the 8th tray's circumferential liner weld joint. It was observed in the upper side wall of the weld approximately at 240 ° (Referred 0° from the internal overflow pipe clockwise).
