AFA INTERNATIONAL WORKSHOP ON

FITNESS FOR SERVICE IN CHEMICAL INDUSTRIES

November 25-27, 2012
Aswan, Egypt

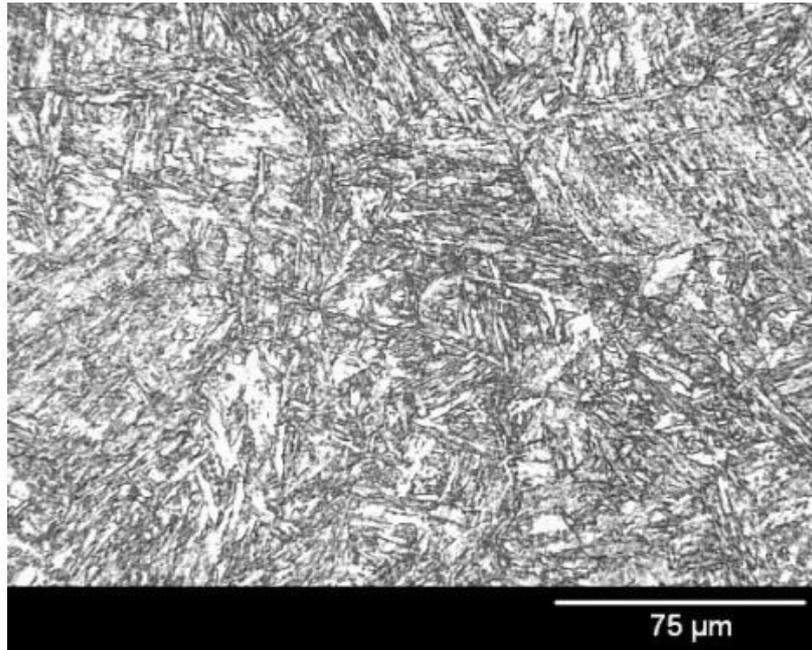
Figure 1: R5 steel microstructure (after Nital etching 2%)

The material studied hereafter is a non-standard hot rolled low alloy steel grade (named R5 according to the International Classification Societies of Off-shore Systems) with a typical fine grain microstructure, composed by tempered martensite and bainite, as shown in Figure 1. Its chemical composition is shown in Table 1. This steel is used after a double quenching in water at 920°C then 880°C and tempering at 650°C with water cooling. After this heat treatment its mechanical properties are: hardness 317 HB, yield strength 970 MPa, UTS=1018 MPa, Young modulus $E=211$ GPa. It has to be noticed that this steel is vacuum degassed with low hydrogen content (1 ppm maximum in the liquid steel after the vacuum treatment). Furthermore, very low non-metallic inclusions are present in this steel (see details in [12]).

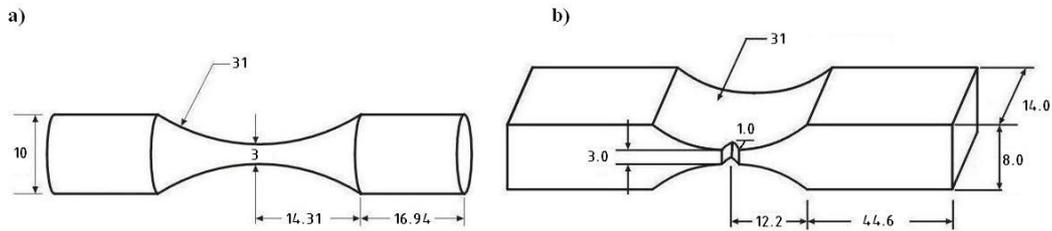
Figure 2 : Specimen geometry for (a) VHCF tests, $K_t=1.02$, (b) crack growth tests (dimensions in mm).

All the fatigue tests (crack initiation and crack growth) presented hereafter were carried out with an ultrasonic fatigue testing machine [1] operating continuously at 20 kHz (no pulse loading) under fully reversed tension ($R = -1$) (see [1, 12] for details). Figure 2 shows the dimensions of the two types of specimens used for (i) VHCF crack initiation tests and (ii) fatigue crack growth (FCG) tests. The geometry of the FCG specimens was designed according to the works of Wu [13] and Sun [14]. The crack growth was measured with an optical binocular microscope with a maximum magnification $\times 200$. The roughness of the tested area of the VHCF specimens was $Ra = 0.6 \mu\text{m}$ and a few additional specimens with a better roughness ($Ra = 0.1 \mu\text{m}$) were tested too for investigating the effect of

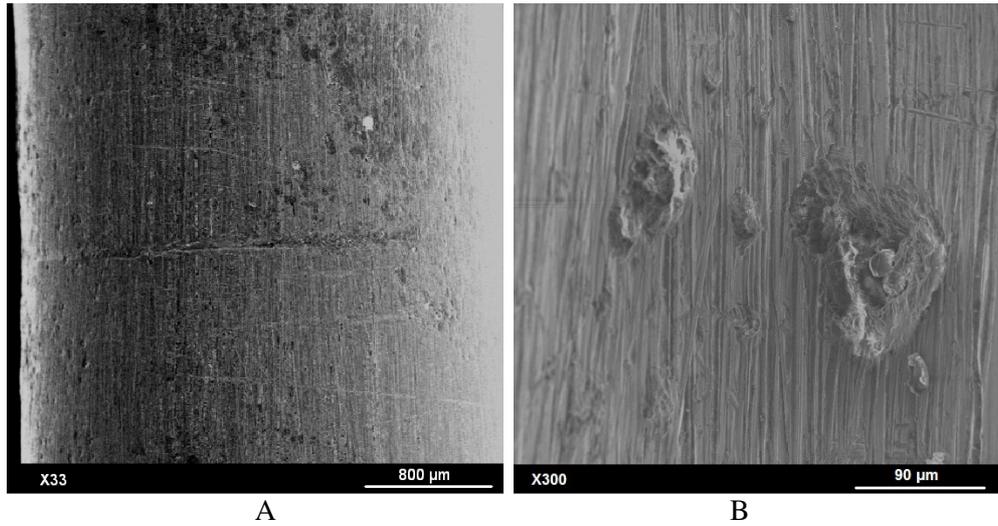
Figure 3: A) Surface of a specimen after pre-corrosion in the salt fog chamber, B) zoom on a corrosion pit.

The pre-corrosion of the specimens was done according to the ASTM G85 standard: 600 hours in a salt fog corrosion chamber under temperature and humidity control (35°C with 95% of humidity). The salt solution contains 5% of NaCl, its pH was 6.6 and it was applied in the chamber with a rate flow of 1.52 ml/h. After the pre-corrosion process the specimens were first chemically cleaned and then cleaned with emery paper to remove the oxide layer. Many corrosion pits were created by the salt fog (Figure 3) their diameter is about 30 to 80 μm .

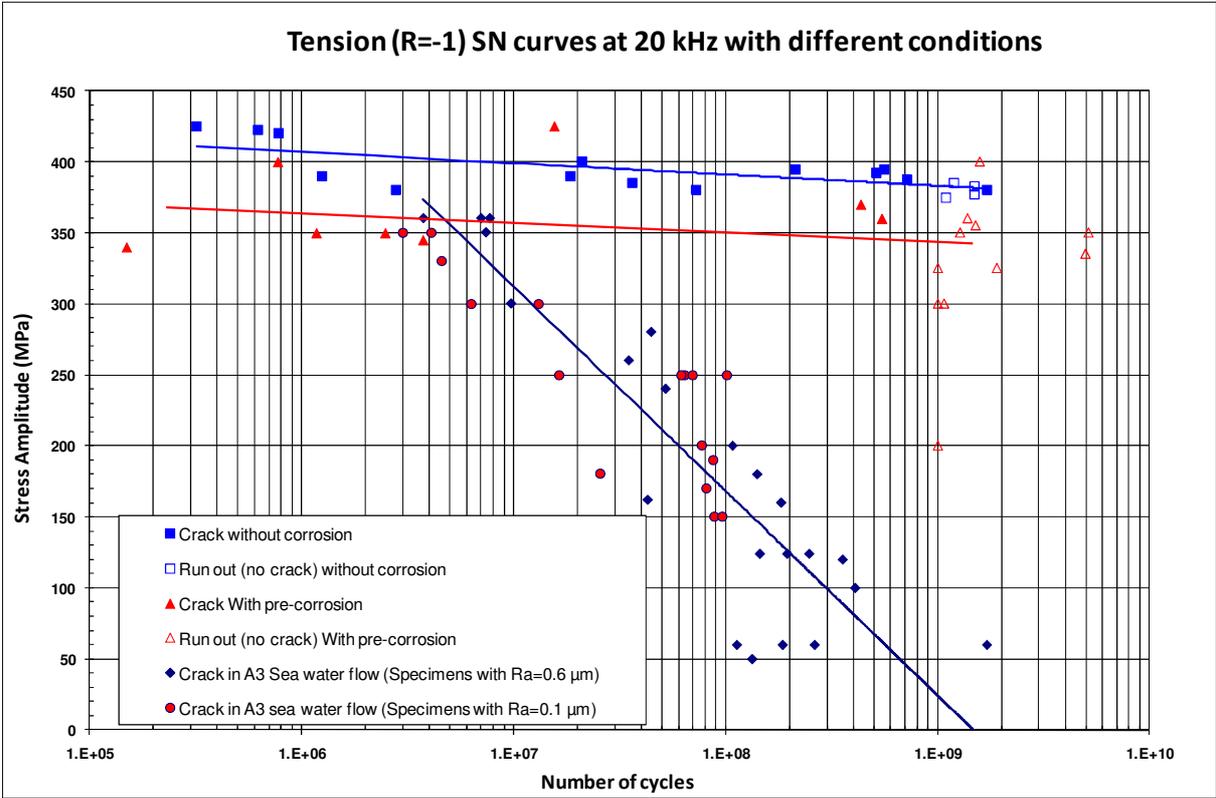
Figure 4 shows the S-N curves of the crack initiation tests. A decreasing of around 50 MPa of the fatigue strength for the specimens with pre-corrosion is observed compared to the specimens without any corrosion. The scatter of the fatigue strength of pre-corroded specimens is larger than for virgin ones. There is a drastic effect of sea water flow on the fatigue strength of the R5 steel in the VHCF fatigue regime. Indeed, for the specimens tested under sea water flow, the fatigue strength at 10^7 cycles is around 300 MPa, not far from the value for pre-corroded specimens (360 MPa), but for 3×10^8 cycles the fatigue strength is around 100 MPa only.

Figure 4: S-N curves of the R5 steel under fully reversed tension at 20 kHz.

since below 56 MPa without any sea water flow there is no failure after 2×10^8 cycles (see the SN curves Figure 4).

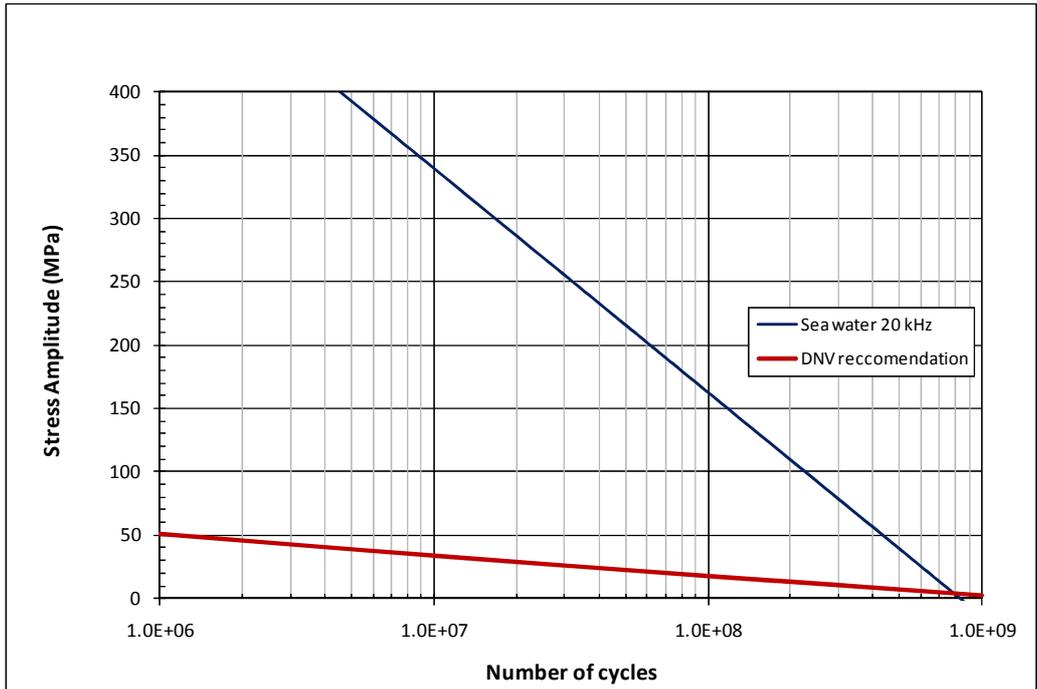
DNV SN Curve approved for R4 and R5 steel (R=0.1)

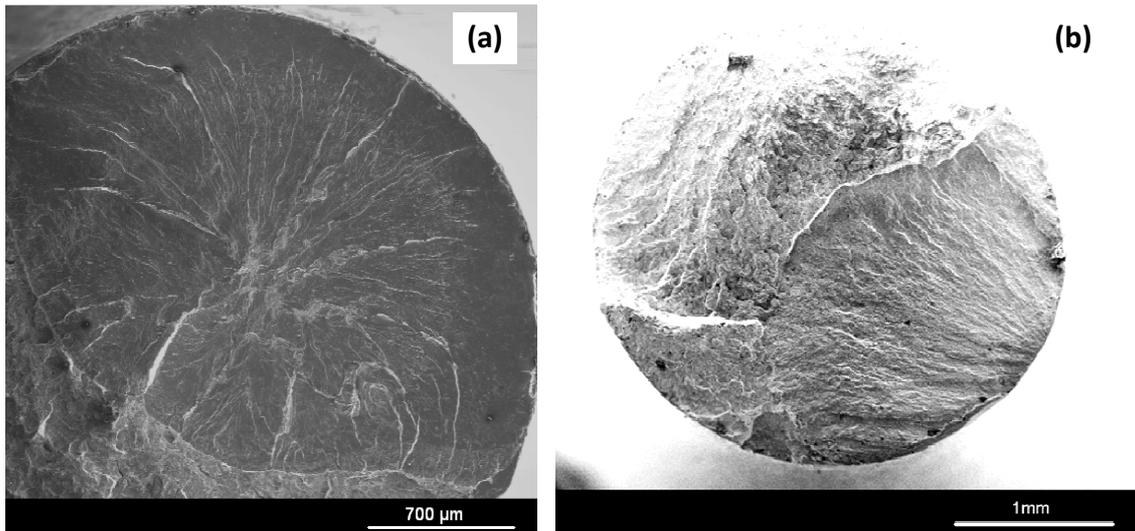
Figure 6: Fracture surface of R5 steel virgin specimens (a) Internal crack initiation $\sigma_a = 380$ MPa, $N = 2.78 \times 10^6$ cycles, (b) surface crack initiation $\sigma_a = 395$ MPa, $N_f = 5.61 \times 10^8$ cycles.

On virgin specimens, even if some unusual internal crack initiations were observed (Figure 6), most of the fatigue cracks initiated at the specimen surface over the cycle range ($10^6 - 10^9$ cycles). Surface defects were the origin of the cracks for non-corroded specimens and corrosion pits for both pre-corroded specimens and specimens tested under sea water flow (Figures 7 – 8). For the specimens tested under sea water flow the crack initiated all around the specimen surface due to several large corrosion pits. The size of the pits depends on the time (i.e. the number of cycles); their diameter is smaller on the pre-corroded specimens (30 to 80 μm) than under sea water flow (50 to 300 μm) (Figures 7 and 8). Furthermore, a lot of small cracks, perpendicular to the loading direction (mode I), were observed at the surface of the specimen tested under sea water flow (Figure 8C); whereas such small cracks were not observed on both virgin and pre-corroded specimens. This is characteristic of a corrosion/cyclic loading interaction.

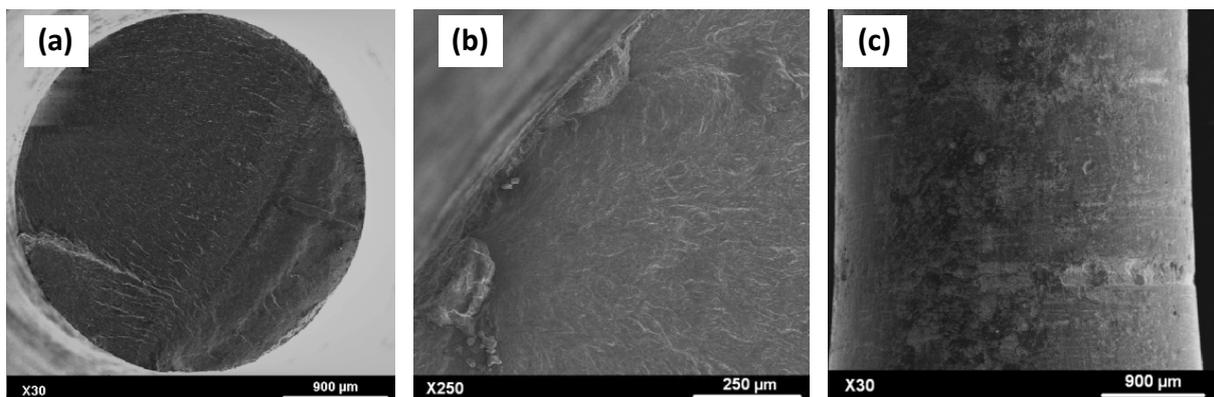
Figure 7: Specimen with pre-corrosion, $\sigma_a = 370$ MPa, $N_f = 4.37 \times 10^8$ cycles

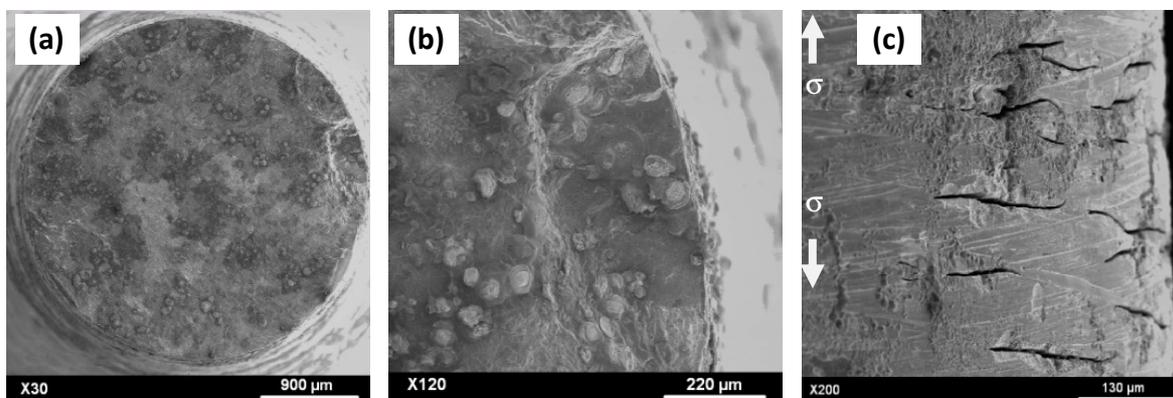
Figure 8: Specimen tested under sea water flow, $\sigma_a = 160$ MPa, $N_f = 1.8 \times 10^8$ cycles.

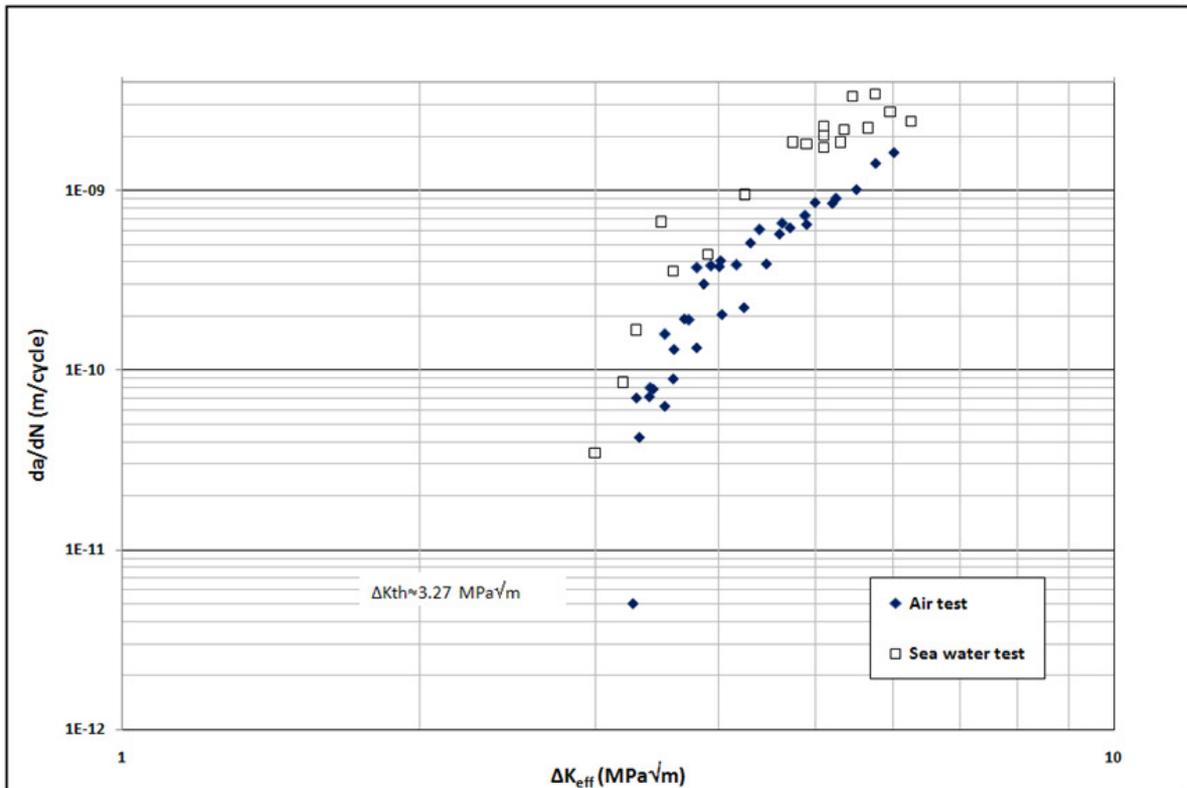
The experimental $da/dN = f(\Delta K)$ curve for the investigated steel is shown in Figure 9. This shows that in air the mode I ($R = -1$) stress intensity threshold for R5 steel is around $3.3 \text{ MPa}\sqrt{\text{m}}$ and as usual the crack growth rate is faster under sea water flow than in air [15]. The fatigue crack propagation duration was assessed according to the work of Paris et al. [8, 9], based on the Paris-Hertzberg-McClintock crack growth model $\frac{da}{dN} = b \left(\frac{\Delta K_{\text{eff}}}{E\sqrt{b}} \right)^3$ and $\left(\frac{\Delta K_{\text{eff}}}{E\sqrt{b}} \right) = 1$ at the corner, where E is the elastic modulus and b is the Burger's vector. The good agreement of this equation with our experimental data and $b = 0.285 \text{ nm}$ was shown in [12]. Since in our experiments at 20 kHz the measurement of K_{op} is not possible, in first approximation $\Delta K_{\text{eff}} \approx K_{\text{max}}$ was assumed and no water interaction with the stress intensity factor was considered.

Figure 9: $da/dN = f(\Delta K)$ curve in mode I for the R5 steel ($R = -1$), in air and under sea water flow at room temperature.

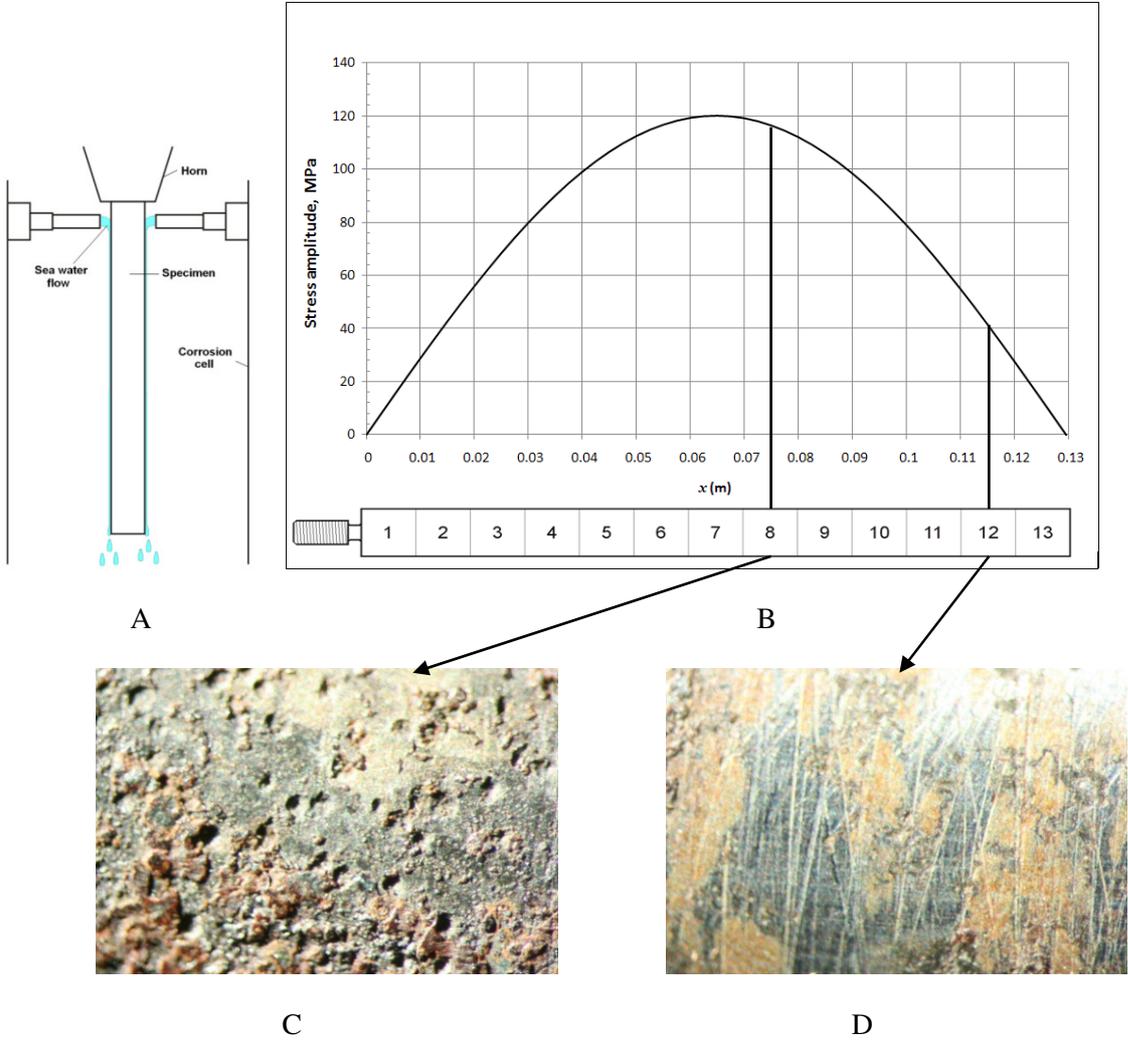
Figure 11: A) schematic illustration of the test principle of a cylindrical specimen with constant cross section under sea water flow, B) evolution of the stress amplitude along the longitudinal axis of the cylindrical specimen for a stress amplitude of 120 MPa in the central cross section, C) and D) optical picture of the specimen surface after 7.37×10^7 cycles in area 8 and area 12 loaded at different stress amplitudes.

Microscopic observations of the cylinder surface showed that R5 steel was damaged by fatigue – corrosion in the areas where the stress amplitude was higher than 56 MPa, a few corrosion traces only were observed where the stress amplitude was smaller (Figure 11D). The final fracture occurred where the stress amplitude was between 112 and 120 MPa. This shows an experimental evidence of the coupling between the corrosion process and cyclic loading, even at ultrasonic frequency (20 kHz),

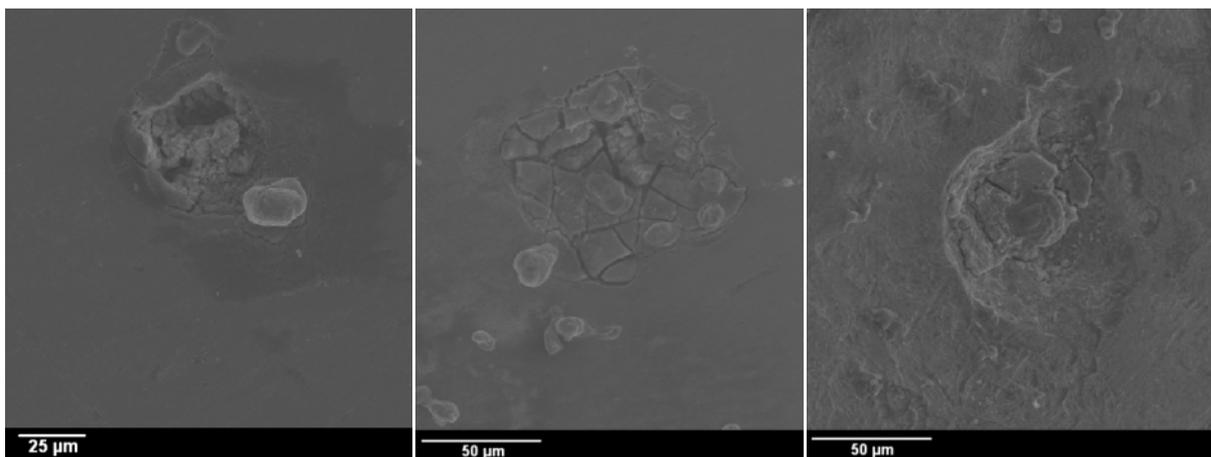
Figure 12: corrosion pits at the surface of a specimen under sea water flow during 13 h 53 min 20 s without any cyclic loading.

specimen surface with the same flow rate than for the tests with cyclic loading. The aim of these tests was to quantify the corrosion damage after the same duration than 10^7 cycles (8mn20s at 20 kHz), 10^8 cycles (1h23mn20s at 20 kHz) and 10^9 cycles (13h53mn20s at 20 kHz). No corrosion trace was observed by SEM after 8mn20s. After 1h23mn20s only a few traces of corrosion appear but not pits were observed. Corrosion pits were observed at the specimen surface after 13h53mn20s. The typical size of these pits was varying between 30 and 60 μm (Figure 12) this is significantly smaller than under simultaneous cyclic loading and sea water flow (Figure 8). The same pit size was observed under sea water flow with a stress amplitude of 240 MPa after 5×10^7 cycles. This corresponds to 42 mn only at 20 KHz! This proves that there is a coupling between corrosion and cyclic loading.

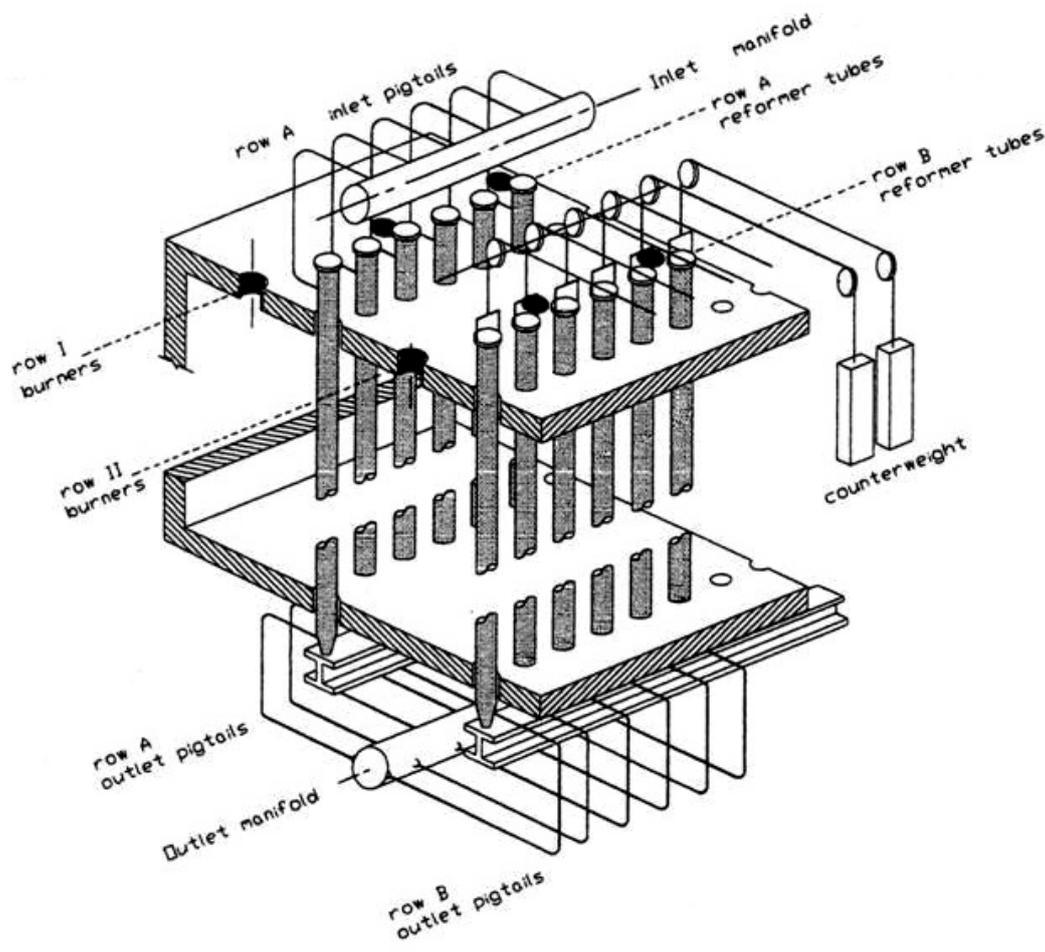
Fig. 1. Schematic view of a top fired reformer furnace

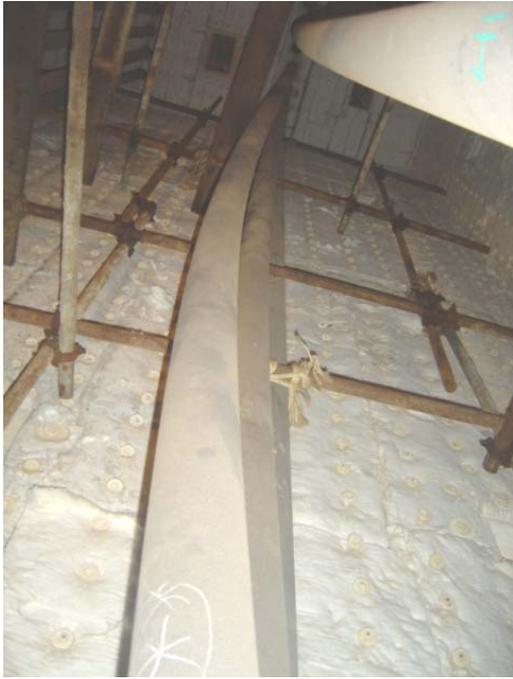
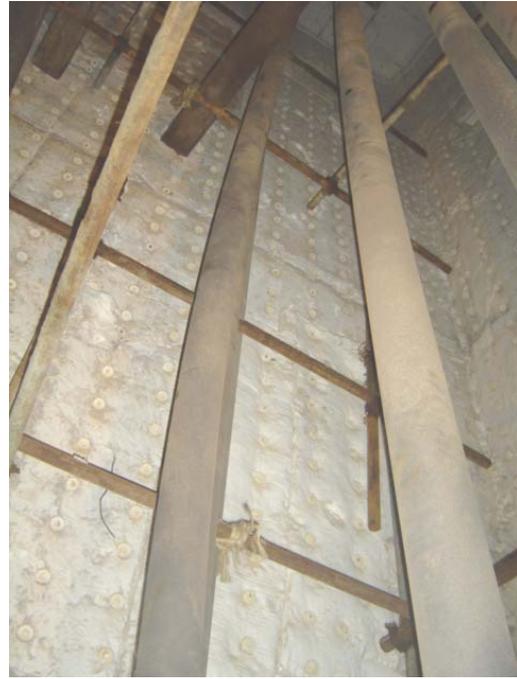
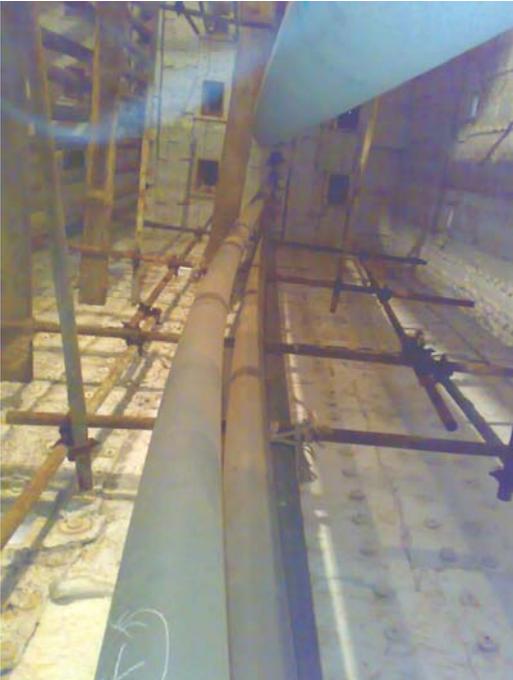
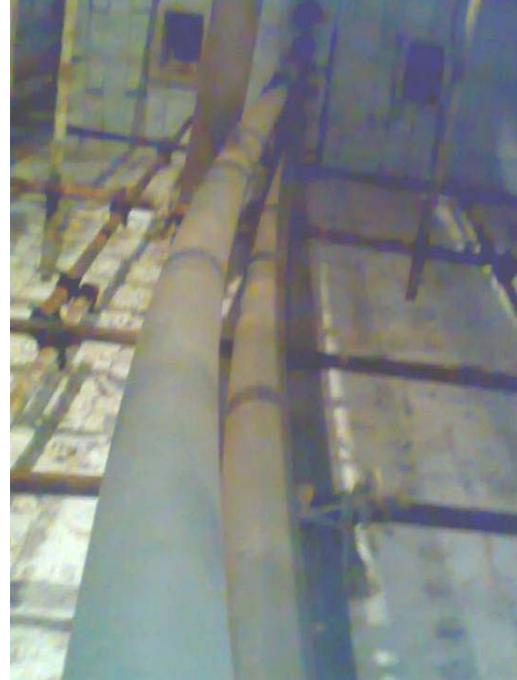
Fig. 3-a Severely bended reformer tubes with color

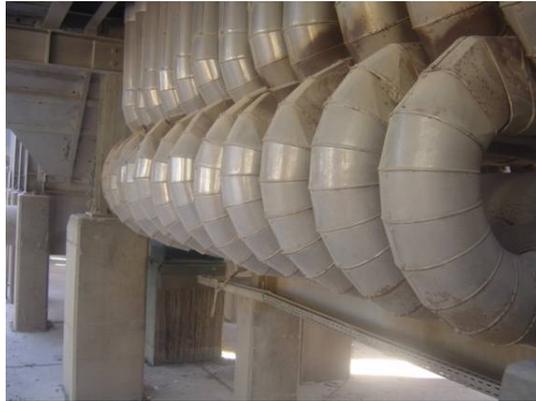
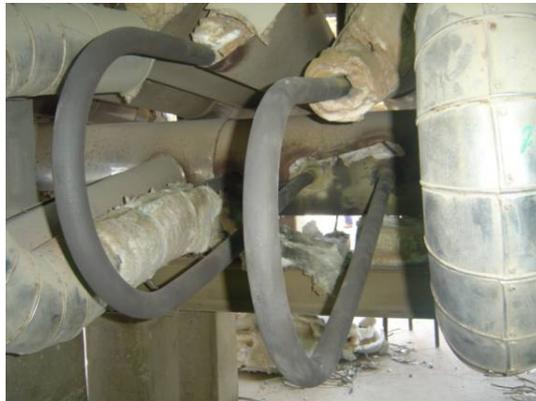
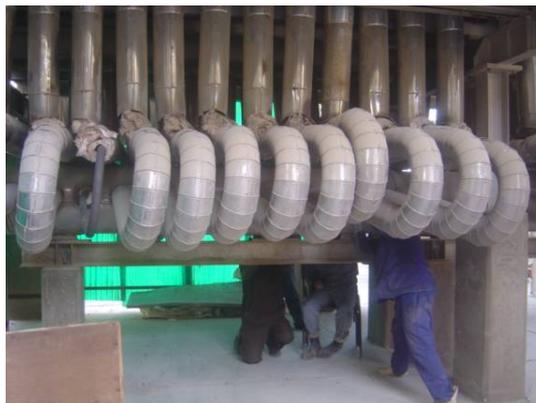
(a) there is no deformation

(b) there is a sever deformation

(c) there is a sever deformation

Fig. 4 The photos show the sever displacement of outlet pig tails, (a) at reformer entrance. (b) at the middle of the reformer and (c) at the end of the reformer

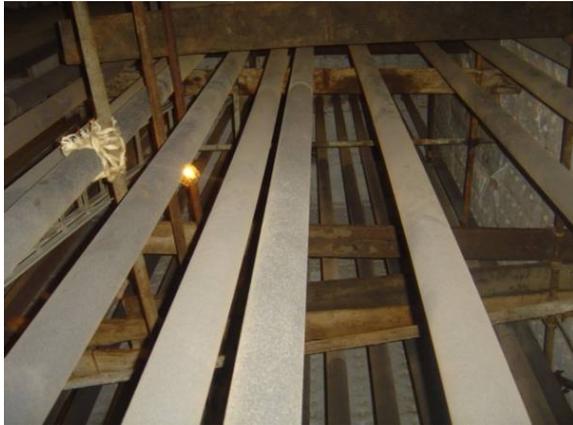
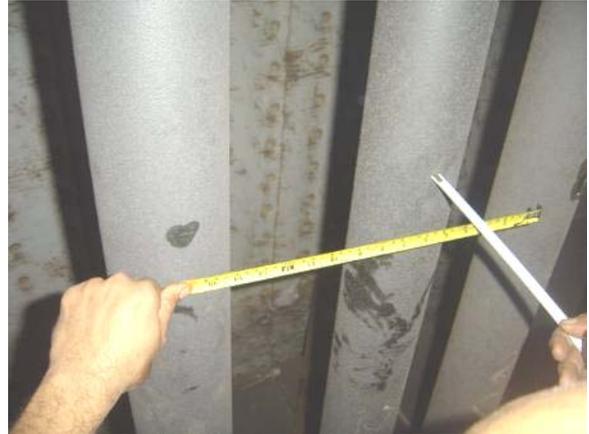
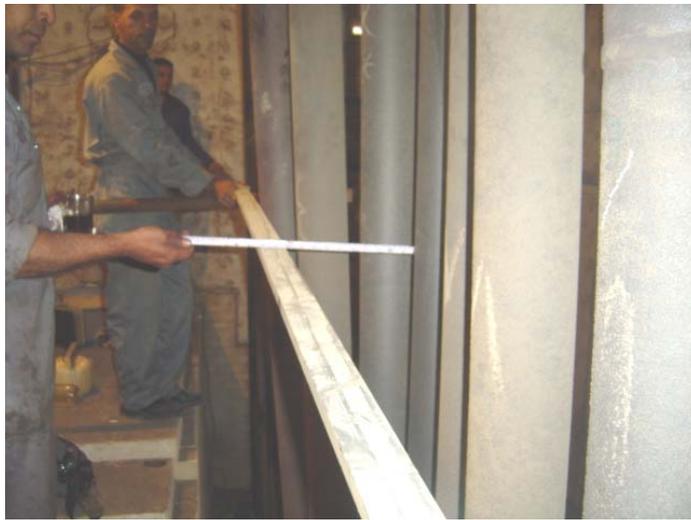
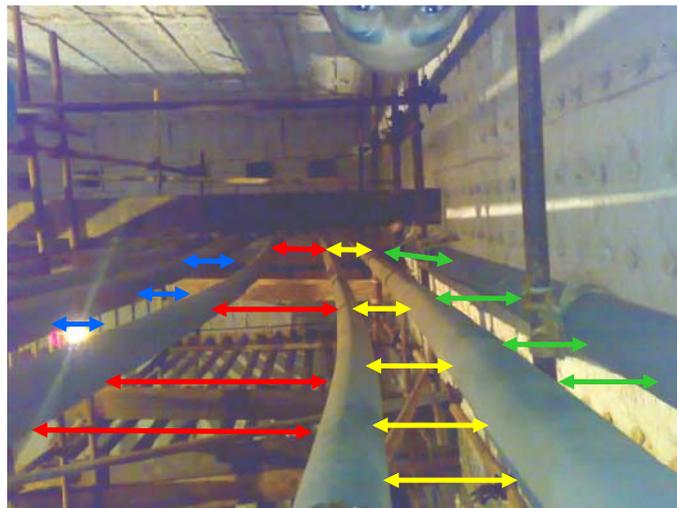
Fig. 5. Variations in internal distance between the tubes as the result of bending

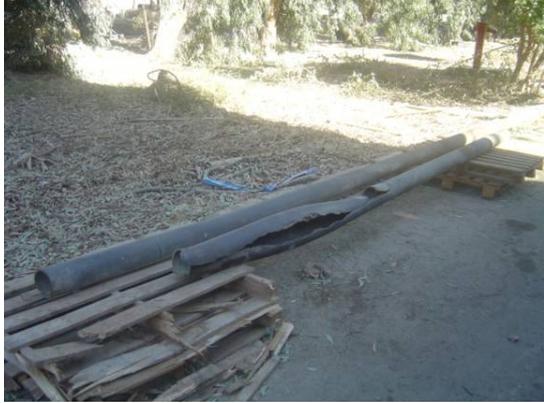
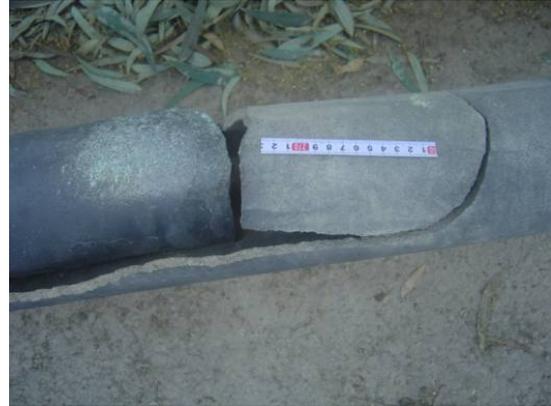
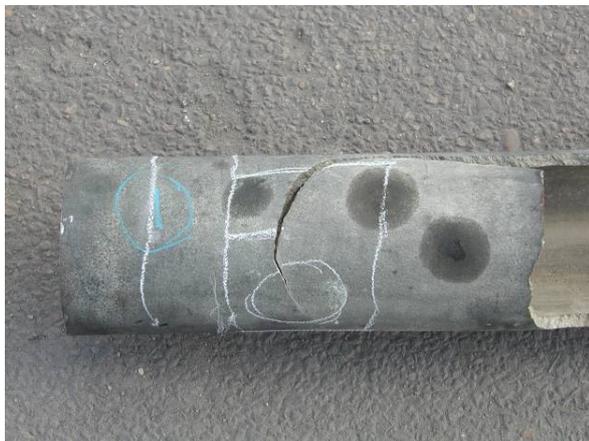
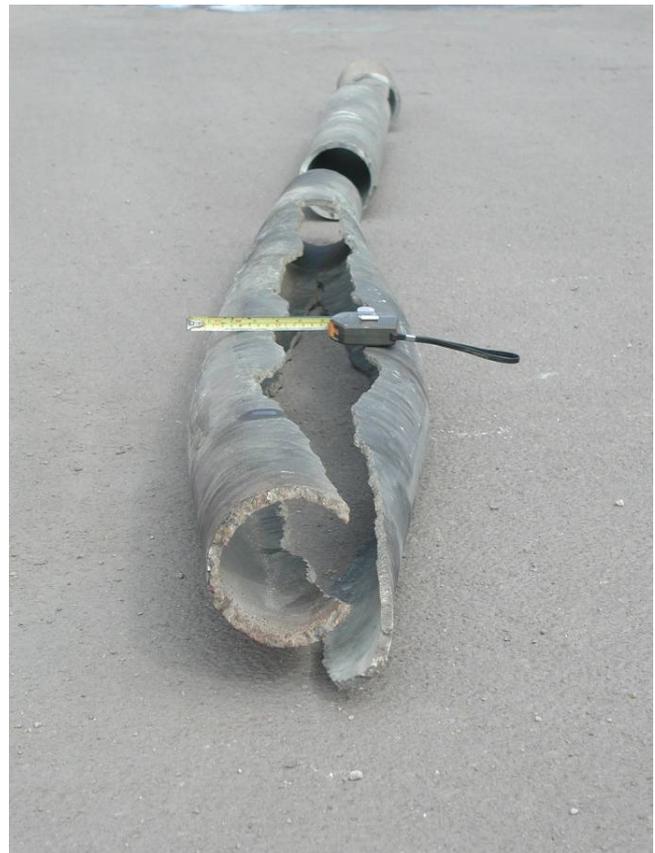
Fig. 6. Severe rupture of reformer tube which took place one year before, the photos show the large increase in tube diameter due to the creep deformation

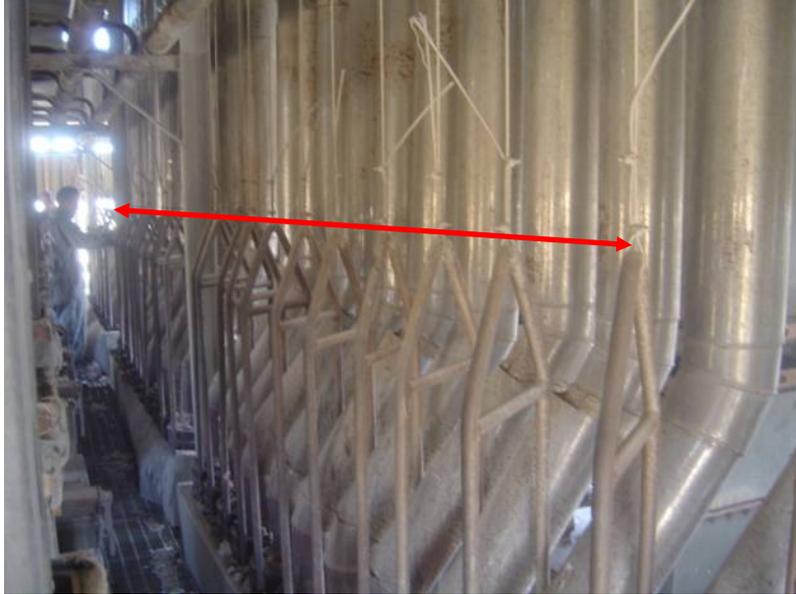
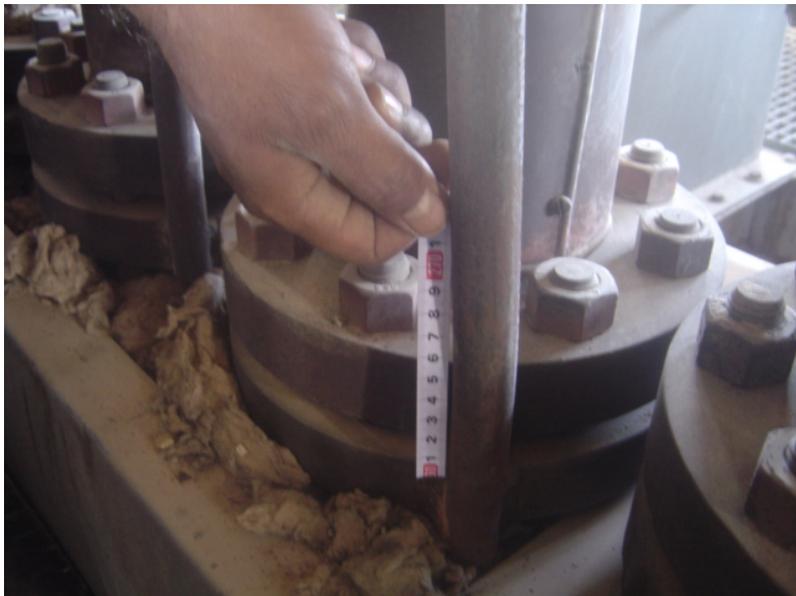
(a) Almost in the same level

(b) There is a bending in the pull rod

Fig. 7. General view on counter weight and

Looking at the counter weights at the roof of the fire box, it was observed that all of them were at the same level and no counter balance had taken place during the past operation of the reformer furnace. Besides, it was also observed that there is bending occurred in one of the pull rods of the counter weight as shown in Fig. 7.

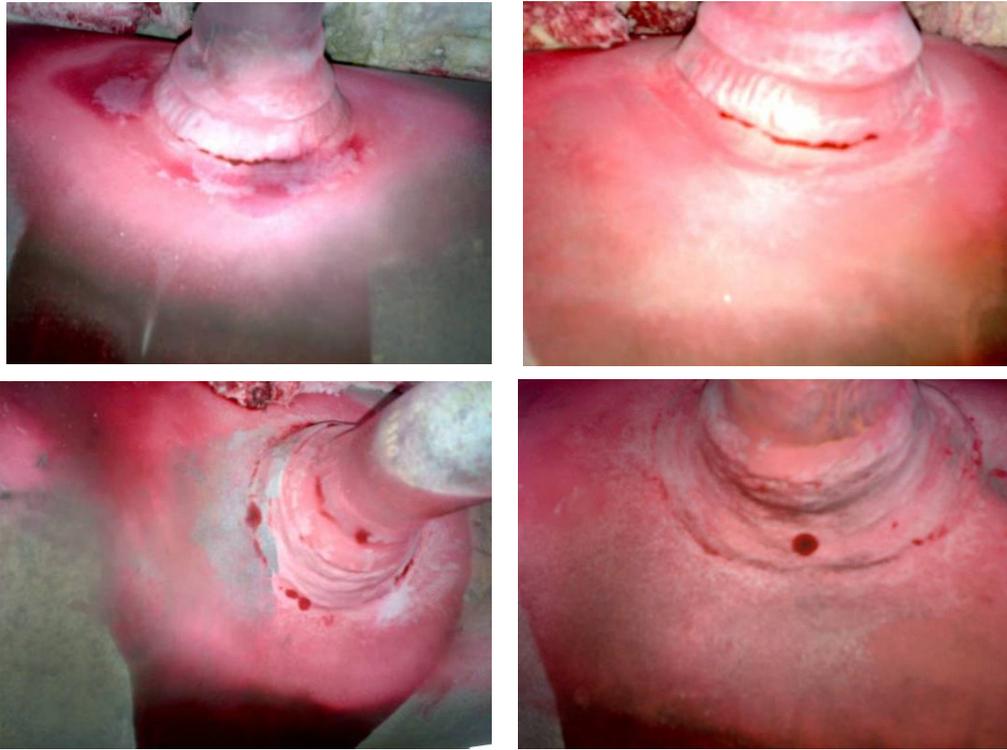
Fig. 8 Cracks at the weld joint of outlet pig tails with the header as revealed by dye penetrant test

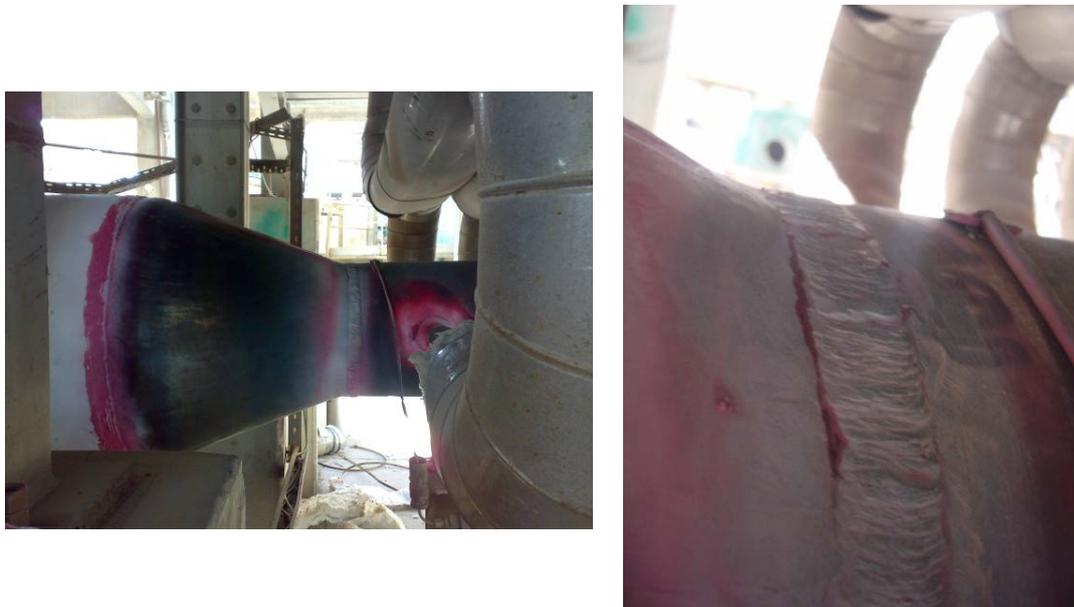
Fig. 9. Cracks at the heat affected zone of weld joint between the outlet header and the reducer

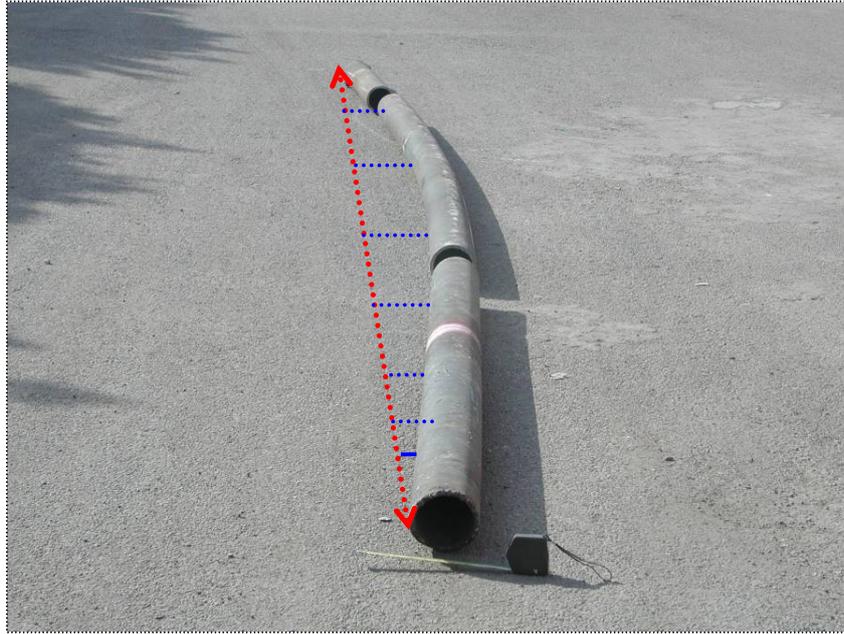
Fig. 10. The photo shows the sever bending of the tube a long its length

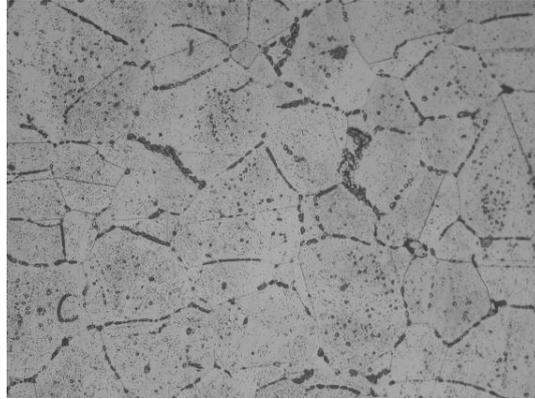
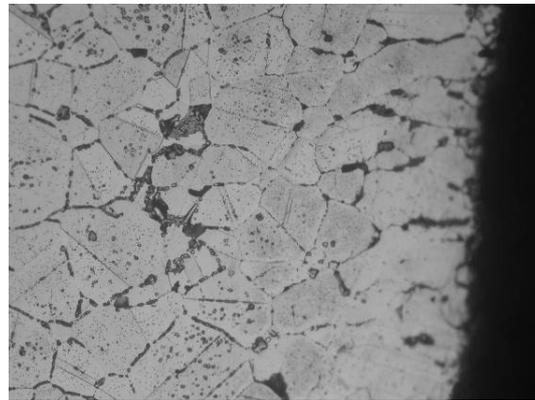
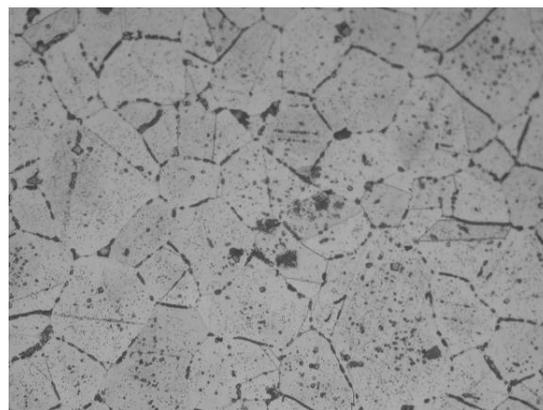
Fig. 14. Microstructure of the pig tail showing relatively large grain size with void formation at grain boundaries

The microstructure of the pig tails specimen is shown in Fig. 14. The microstructure reveals considerable number of creep voids formation at the grain boundaries of the alloy 800H with coarse secondary carbides precipitation within the grains which means that the pig tails were exposed to a higher temperature where creep voids started to occur.

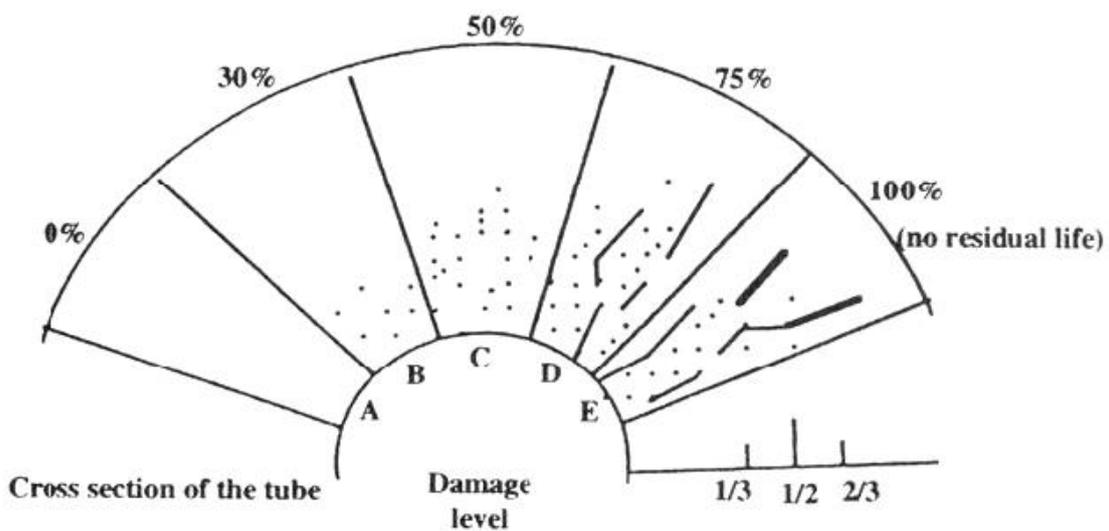
Fig. 15. Classification of the damage in the wall of a reformer tube, as indicated after metallographic preparation.

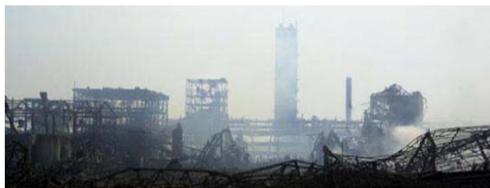
A huge explosion ripped through AZF (Azote de France) fertilizer factory in an industrial zone on the outskirts of Toulouse, southwest of France, at 10:15 am, Friday 21 September 2001. The explosion occurred in a warehouse in which stored granular ammonium nitrate.

The amount is said to be between 200 to 300 tonnes of ammonium nitrate, used to make fertilisers. The explosion had been caused by an accident following an "incident in the handling of products". The exact cause remains unknown.

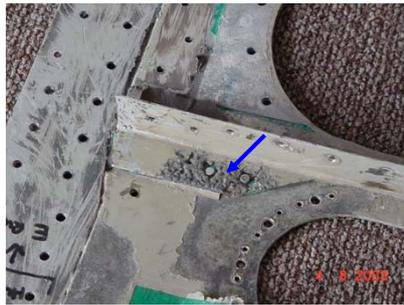
Pitting and Pillowing

Pitting

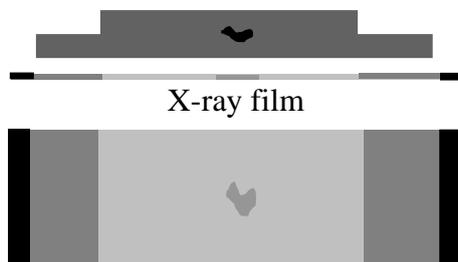
The part is placed between the radiation source and a piece of film. The part will stop some of the radiation. Thicker and more dense area will stop more of the radiation.

The film darkness (density) will vary with the amount of radiation reaching the film through the test object.

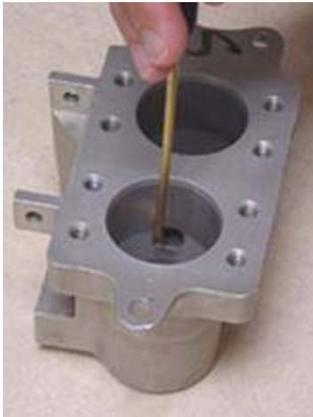
Eddy Current Testing

Eddy current testing is particularly well suited for detecting surface cracks but can also be used to make electrical conductivity and coating thickness measurements. Here a small surface probe is scanned over the part surface in an attempt to detect a crack.

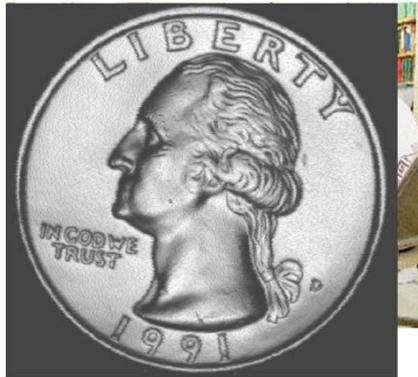
Ultrasonic Imaging

High resolution images can be produced by plotting signal strength or time-of-flight using a computer-controlled scanning system.

Gray scale image produced using the sound reflected from the front surface of the coin

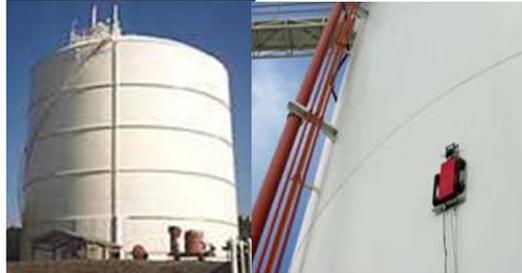
Storage Tank Inspection

Robotic crawlers use ultrasound to inspect the walls of large above ground tanks for signs of thinning due to corrosion.

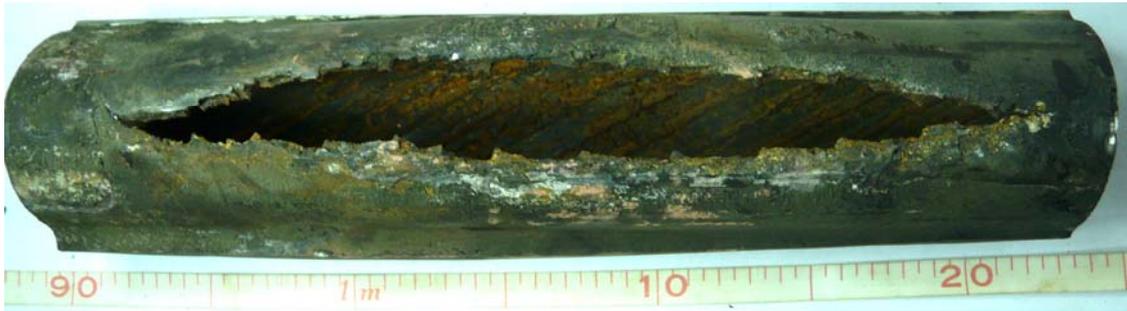
View of the fracture side

Fig. 1 General views of the received ruptured tube sample.

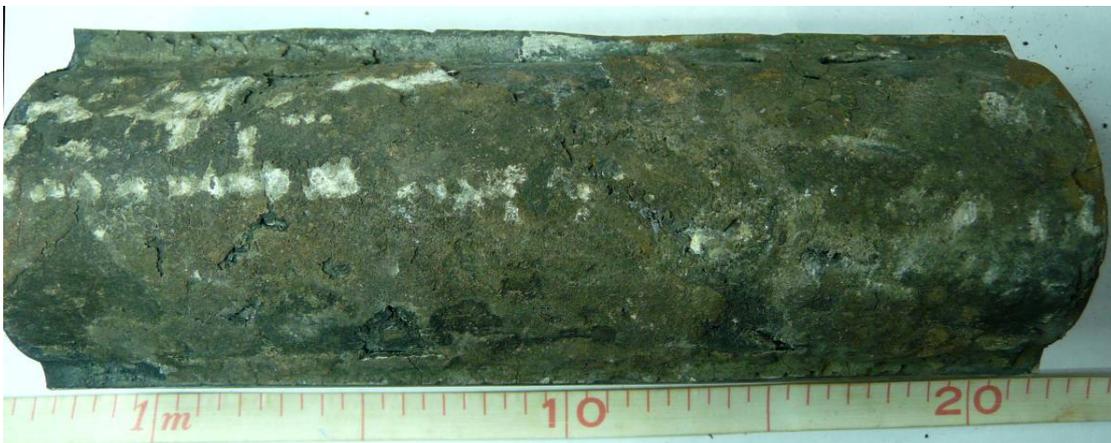
Fig. 2 General views of the received in-service-non-ruptured tube sample.

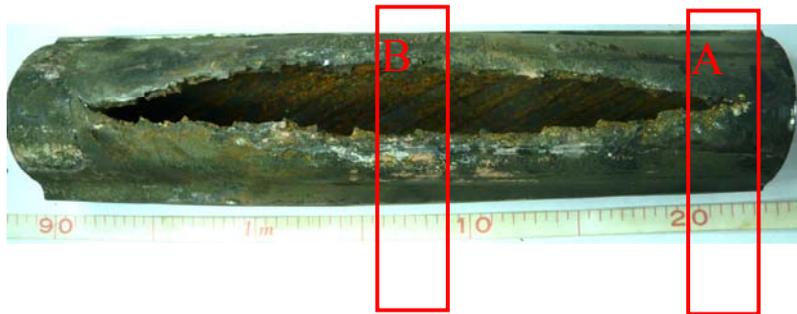
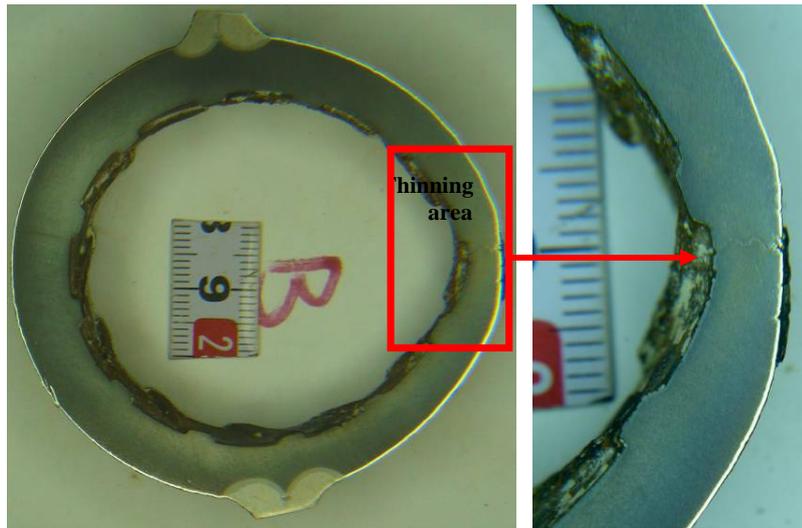
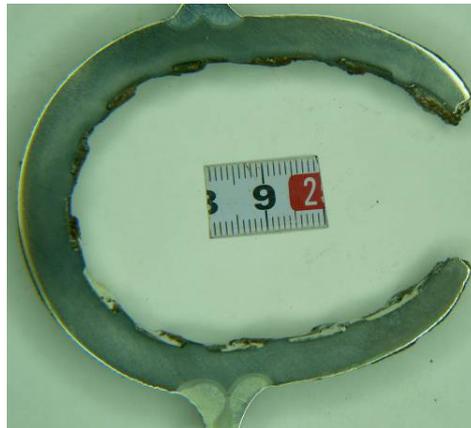
(a) General view of the received ruptured tube

(b) Views of the ruptured tube cross-section at the beginning of the fracture (section A in (a))

(c) View of the ruptured tube cross-section at the center of the fracture (Section B in (a))

Fig 9 View of the ruptured tube cross-section at different locations showing the tube bad ovality and its thinning at the fire side.

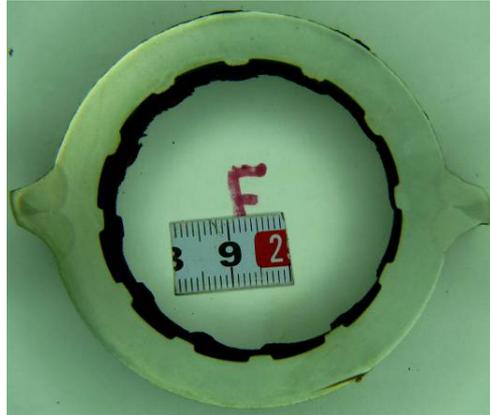
Fig 4 View of the in-service-non-ruptured tube cross-section showing good tube ovality.
