AFA INTERNATIONAL WORKSHOP ON

FITNESS FOR SERVICE IN CHEMICAL INDUSTRIES

November 25-27, 2012
Aswan, Egypt

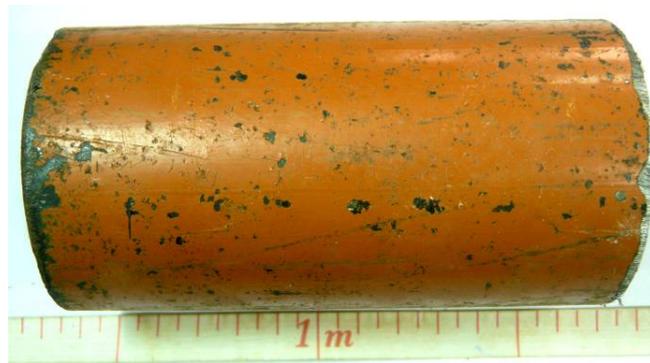
(a) View of the received new tube

Metallographic examinations were conducted on several samples cut from the received tubes (ruptured, non-ruptured, and new tube) and the results are shown in Figs. 6-10. Microstructure of the received ruptured tube at the fire side exhibited ferrite and almost complete decomposition of pearlite. Eventually, at the ruptured edges, the pearlite carbide plates vanished altogether. Another important notice in this critical area is the formation of isolated voids particularly, on grain boundaries of the fractured edges (See Fig. 6). These microstructural observations (pearlite decomposition and voids formation) were detected also in areas apart from the fracture at the fire side (See Fig. 7 (a)). At areas relatively away from the fracture edges, but still at the fire side (90° from the fracture edges), small volume fraction of pearlite in grey color (traces) are detected (See Fig. 7 (b)). On the other hand, the other side (180° from the fracture edges) showed normal ferrite (white) – pearlite (grey) structure with lamellar pearlite structure (See Fig. 8).

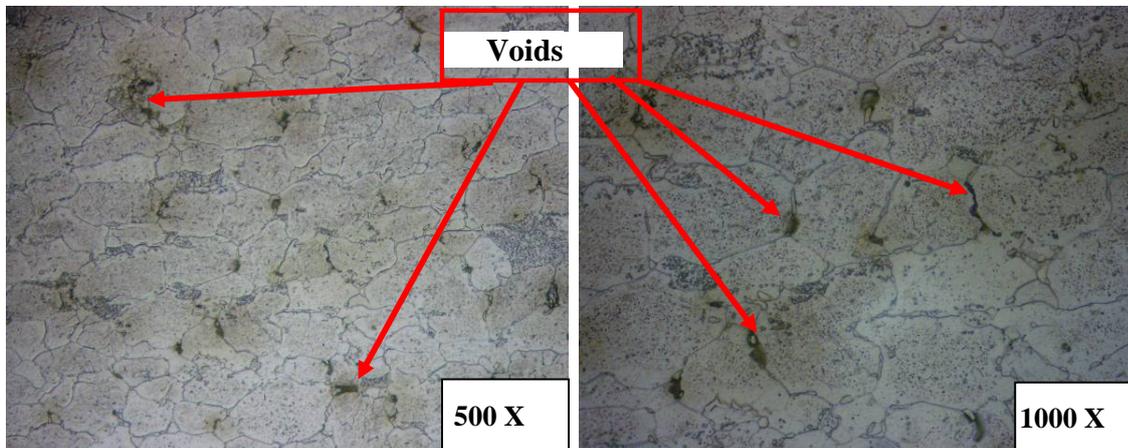
(b) At the fracture edges (Section B)

Fig. 6 Micrographs of the ruptured tube microstructure at the fracture side showing complete deteriorated structure (ferrite+ decomposed pearlite+ grain boundaries voids).

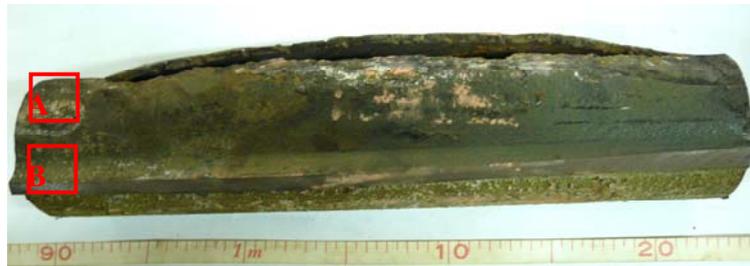
(a) At area before fracture (complete deteriorated structure) (Section A)

Fig. 7 Micrographs of the ruptured tube microstructure at the fire side before fracture showing deteriorated structure at the fracture line and partial deteriorated structure at area far from it.

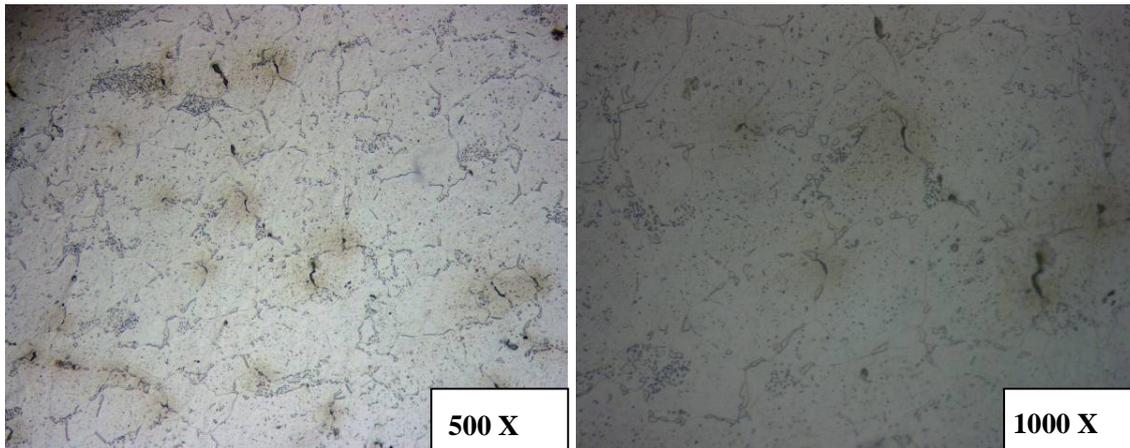
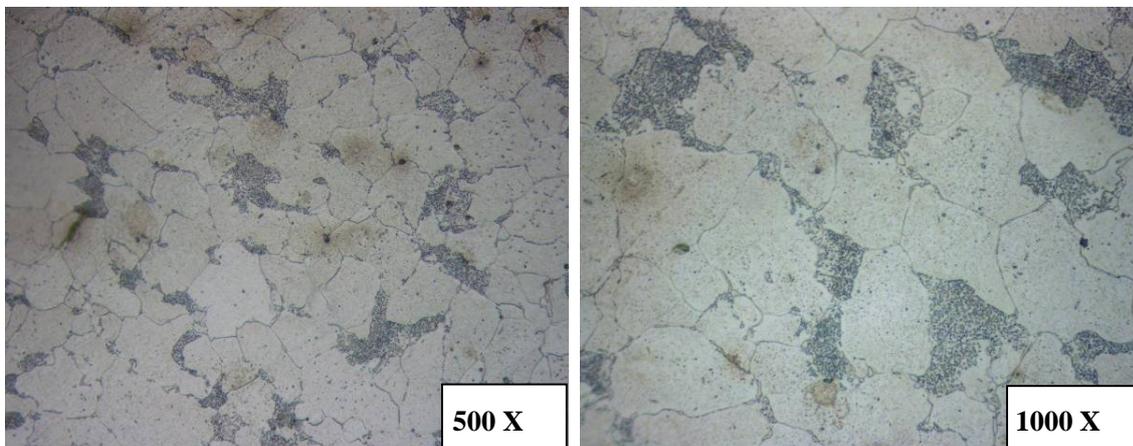
(b) At area 90° from the fracture edges (partial deteriorated structure) (Section B)

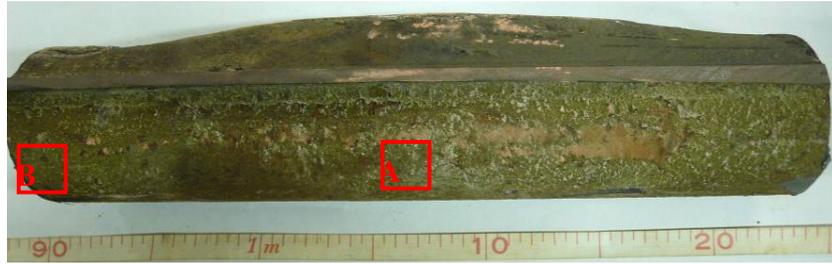
(a) At the fracture area (Section A)

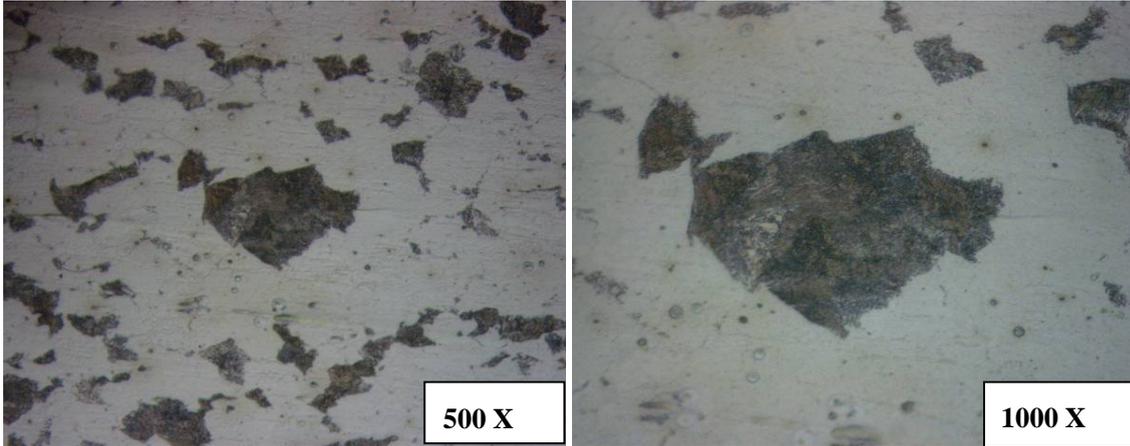
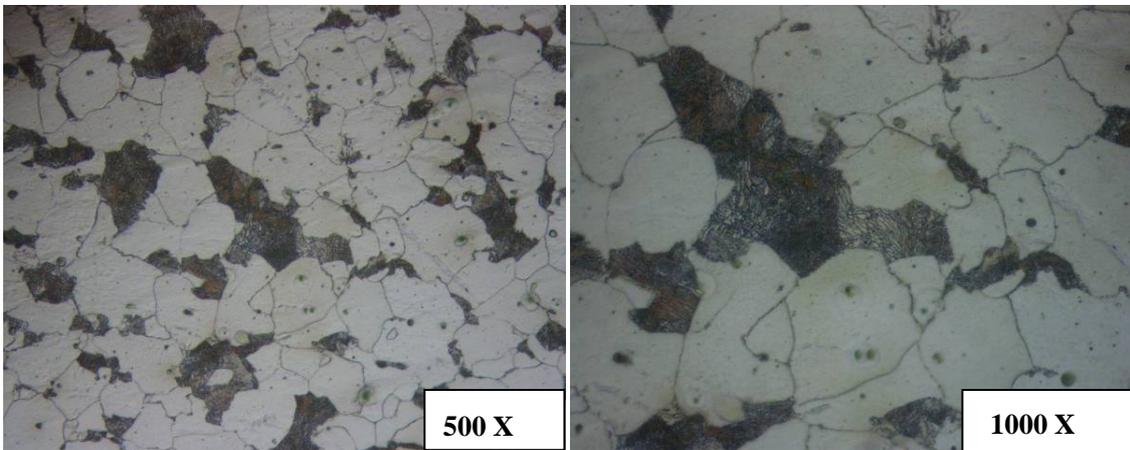
b) At area relatively far from fracture (Section B)

Fig. 8 Micrographs of the ruptured tube microstructure at the other side (180° from the fracture edges) showing normal ferrite (white) – pearlite (grey) structure with lamellar pearlite structure.

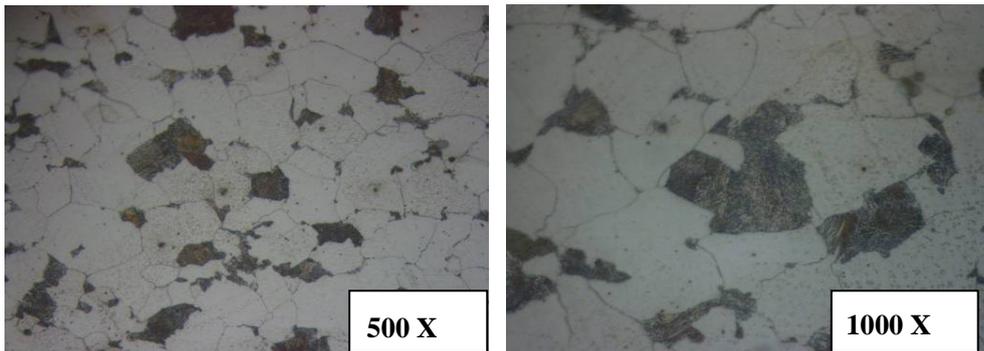
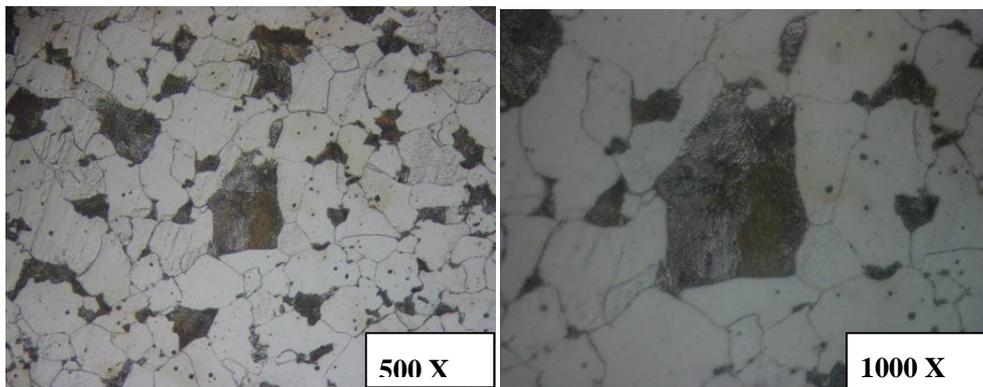
(a) At the fire side showing partial deteriorated structure

b) At the other side (180° from the fire side) showing normal structure.

Fig. 9 Micrographs of the in-service-non-ruptured tube microstructure at different locations showing partial deteriorated structure at the fire side and normal ferrite- pearlite structure at the other side.

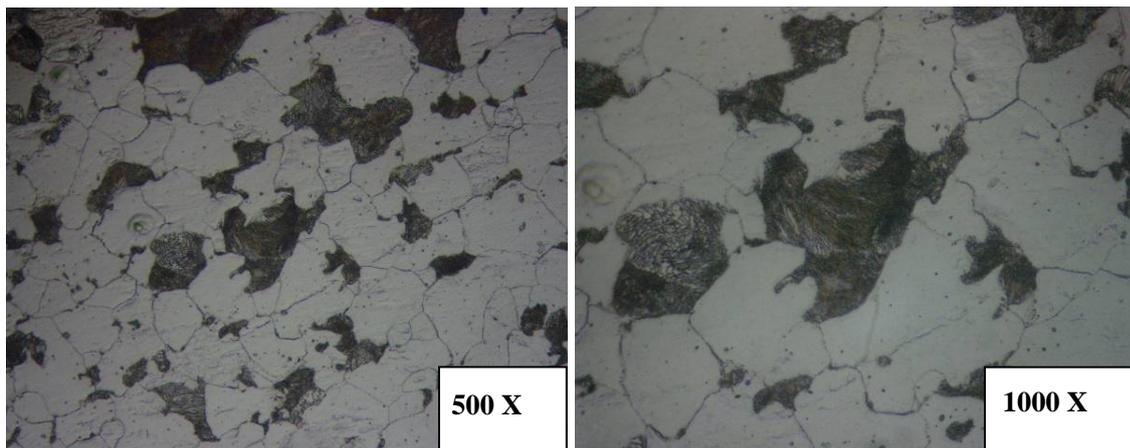
Fig. 10 Micrographs of the new tube microstructure showing normal ferrite- pearlite structure.

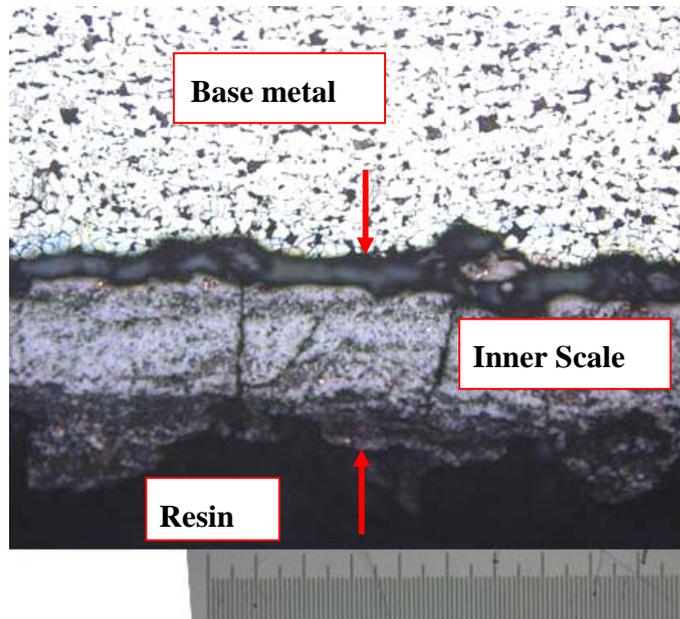
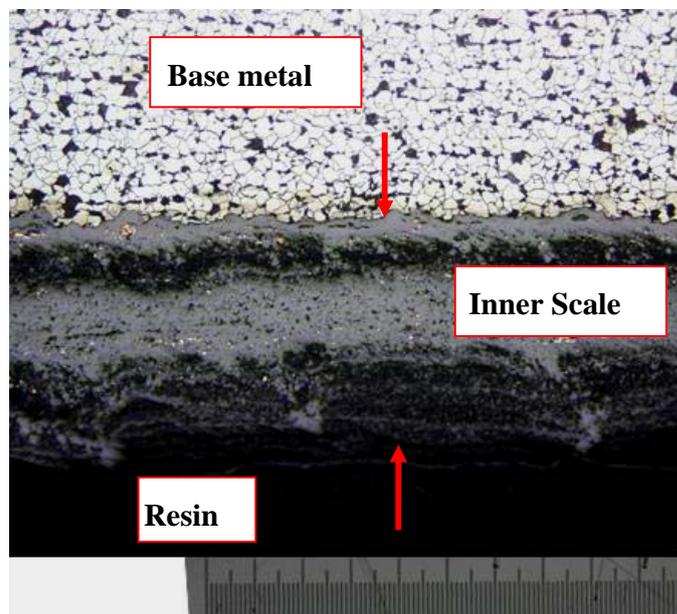
(a) Ruptured tube (~410 μm)

(b) In-service-non-ruptured tube (~510 μm)

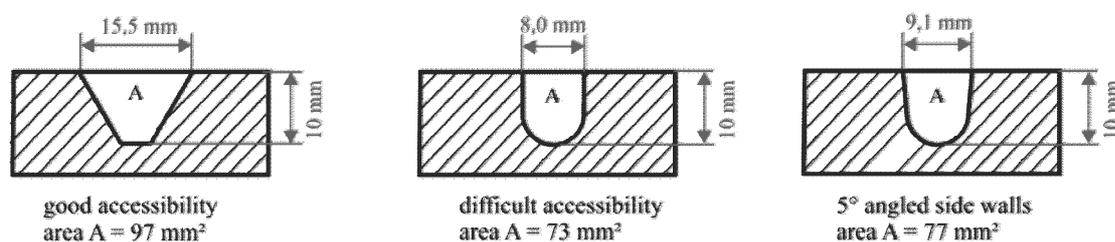
Fig. 1. Specimen: a) V-groove; b) U-groove; c) U-groove with angled side walls

Specimens with three different groove shapes were prepared by milling. In this case-study it was assumed that intolerable defects extend not deeper than 10 mm from the surface, therefore a groove depth of 10 mm was chosen. Acetone was used to clean the groove after milling. The specimens differ in the necessary volume that has to be filled and in the accessibility for the laser beam and the powder jet. The specimens are shown in figure 1.

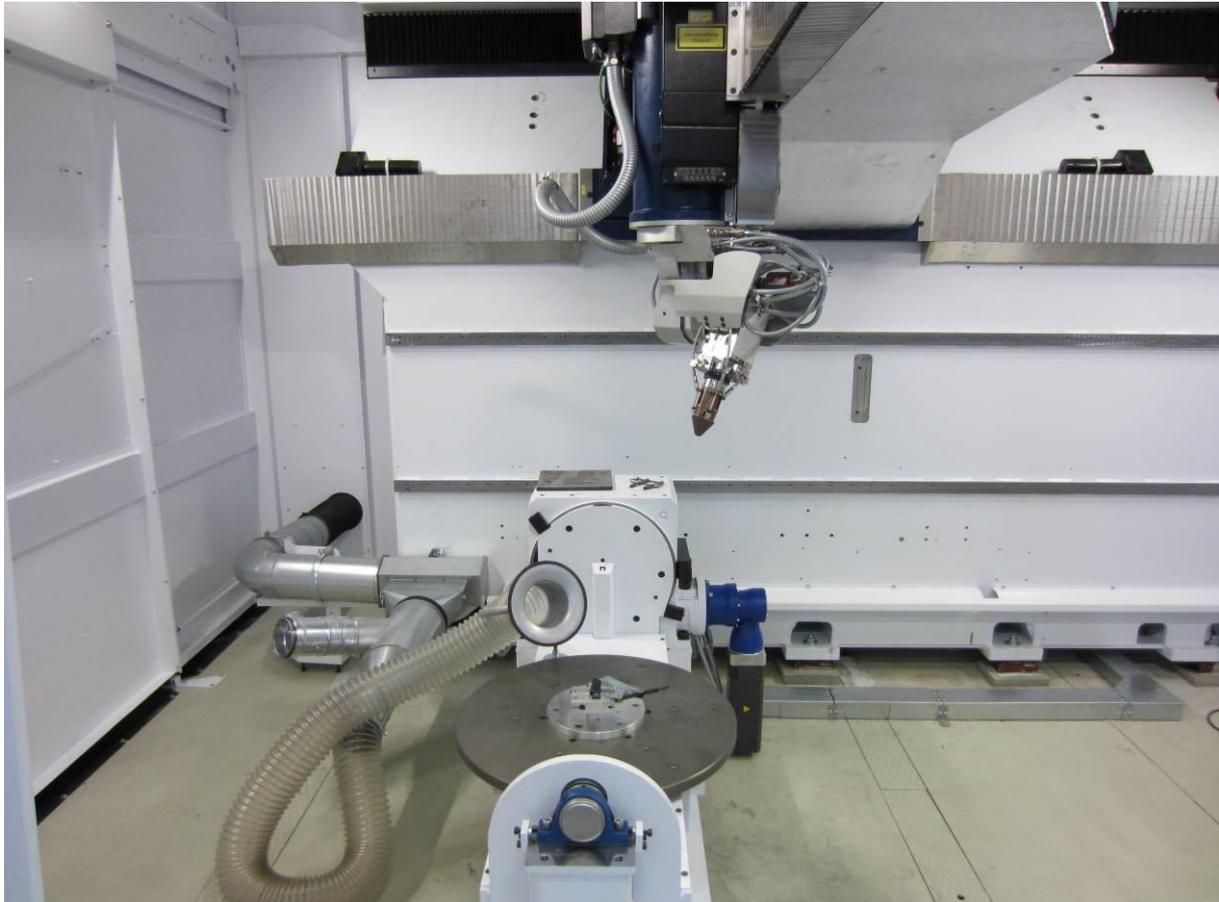
Fig.2 Equipment for laser metal deposition with 2kW disc laser

The metal deposition was done layer by layer. Each layer is made by welding multiple adjacent tracks. After each layer, the powder nozzle was elevated a defined distance, in order to build a three dimensional deposition consecutively.

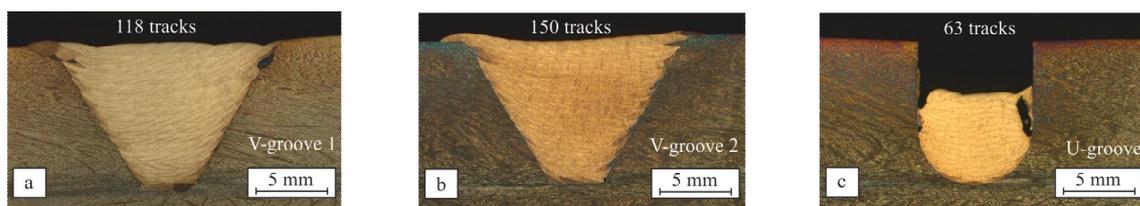
Fig. 3. Cross sections and X-ray testing, stainless steel,

a) $v = 0.5 \text{ m/min}$, $P = 1.0 \text{ kW}$; b) $v = 1.0 \text{ m/min}$, $P = 1.0 \text{ kW}$; c) $v = 1.0 \text{ m/min}$, $P = 1.0 \text{ kW}$

The cross-section of the U-shaped groove (Fig. 3c) shows defects at the side-wall of the groove. Because of accessibility issues, the laser beam couldn't be adjusted perpendicular to the side-wall, resulting in irregular material deposition. Part of the powder jet was impeded by the upper lip of the groove, causing irregularities in the powder stream close to the groove side-walls. In this region, the safe deposition of powder is hindered. Wider grooves or inclined side-walls are necessary.

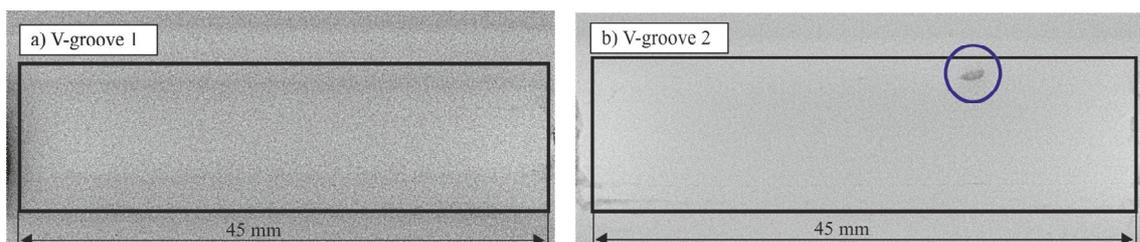
Fig. 4. X-ray testing, stainless steel, a) $v = 0.5 \text{ m/min}$, $P = 1.0 \text{ kW}$; b) $v = 1.0 \text{ m/min}$, $P = 1.0 \text{ kW}$

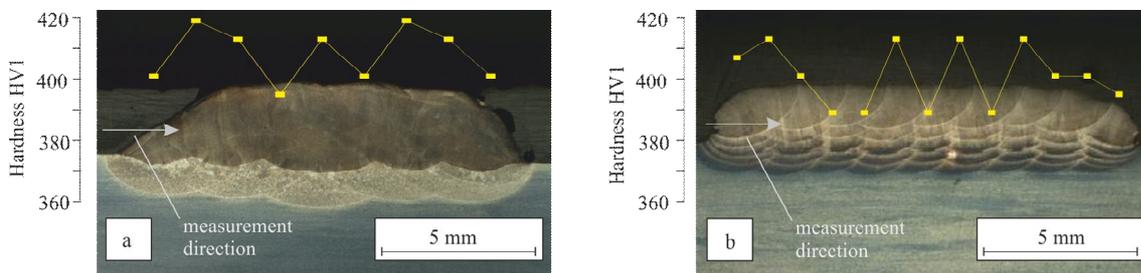
Fig. 5. Cross sections and hardness measurement of titanium alloy Ti-6Al-4V; a) $v = 0.5$ m/min, $P = 2.0$ kW; b) $v = 1.0$ m/min, $P = 1.0$ kW

Figure 5 shows the influence of the welding parameters on the track size. It is possible to use low welding velocity and a high laser power to get single tracks with a height of about 2 mm (Fig. 5a). But due to slow cool down times, an additional inert gas nozzle was needed. The cross section b) shows smaller track sizes that were deposited with only one fourth of the energy input per unit length. No additional inert gas nozzle was used. Between the different layers, no heat tint was observed.

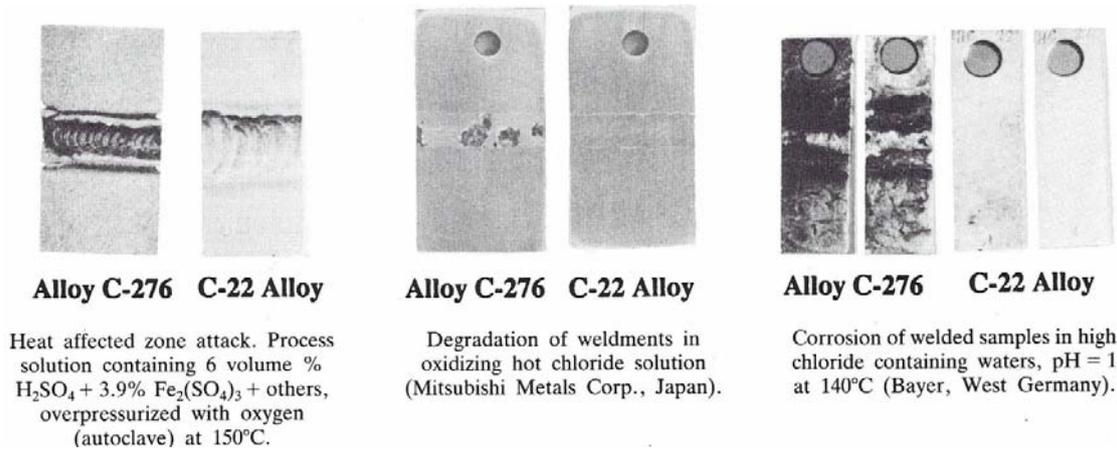
Figure 2. Corrosion Behavior of Welded Samples Showing the Improved Performance of C-22 Alloy Over That of Alloy C-276.

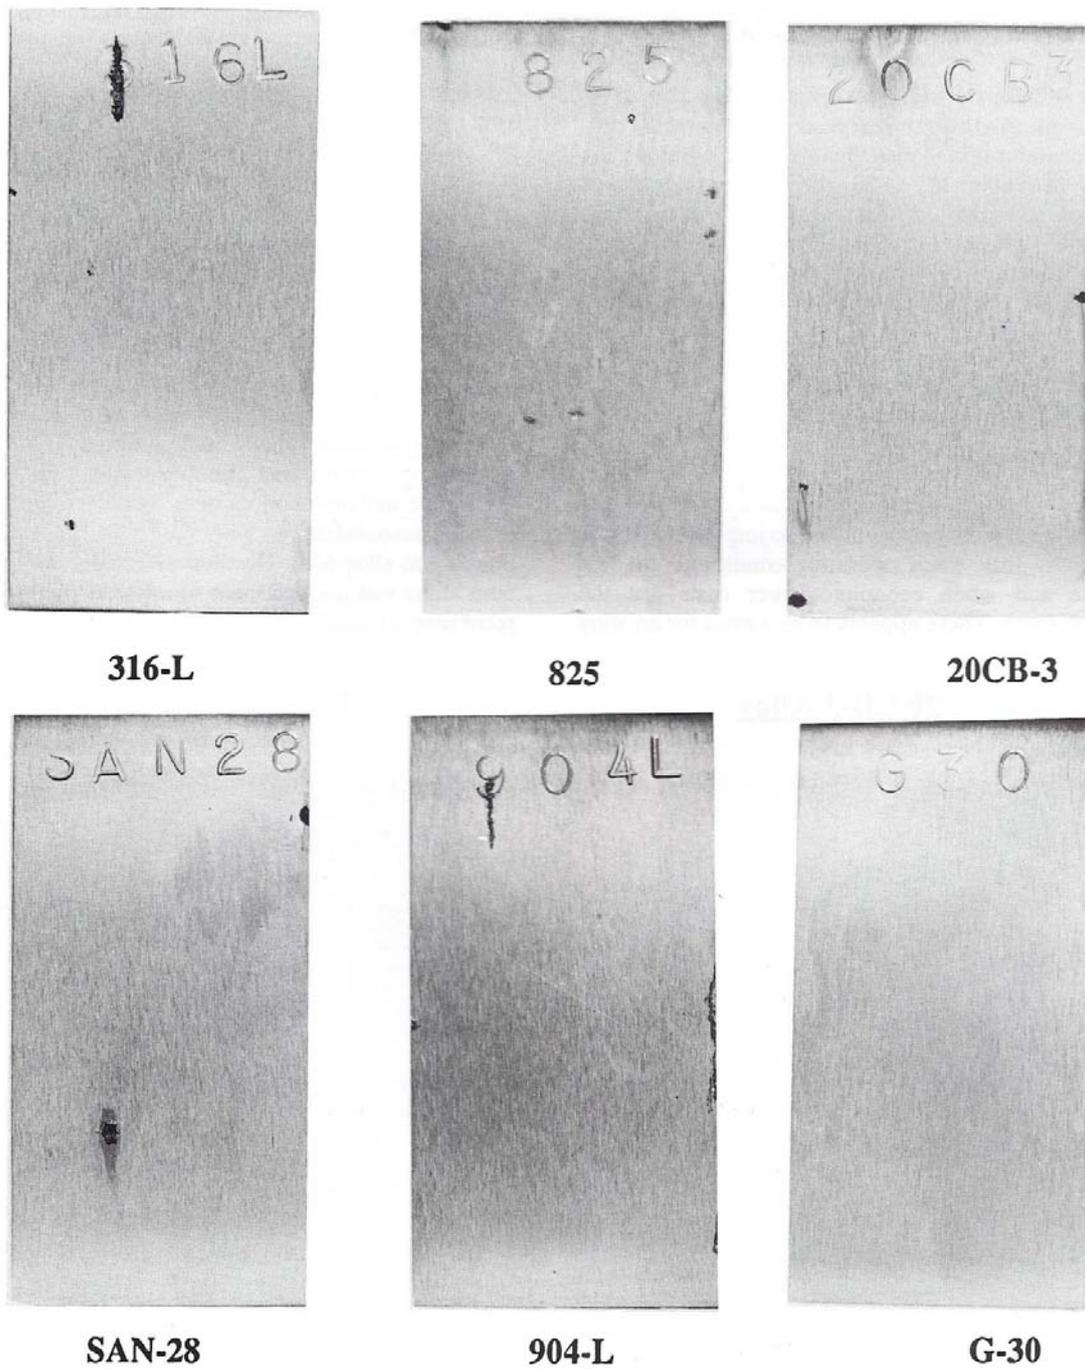
Figure 3. Comparison of Pitting Resistance as Illustrated by Tests in 4% NaCl + 0.1% Fe₂ (SO₄)₃ + 0.01M HCl at 65°C (149°F).

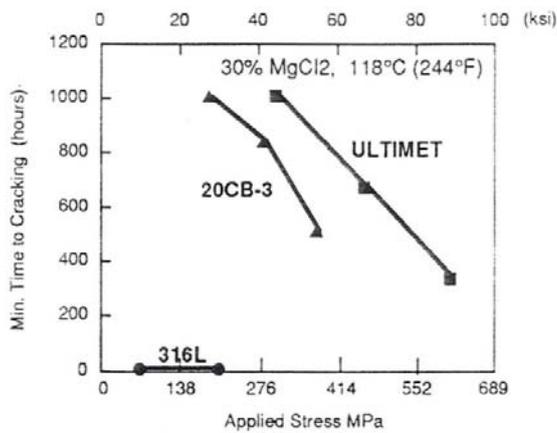
Figure 7. Effect of Applied Stress on Resistance to Cracking.

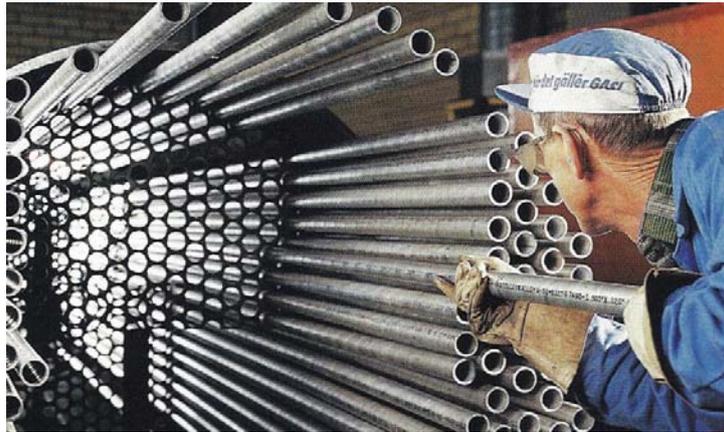
Figure 8. Super Phosphoric Acid Production (Heat Exchanger).

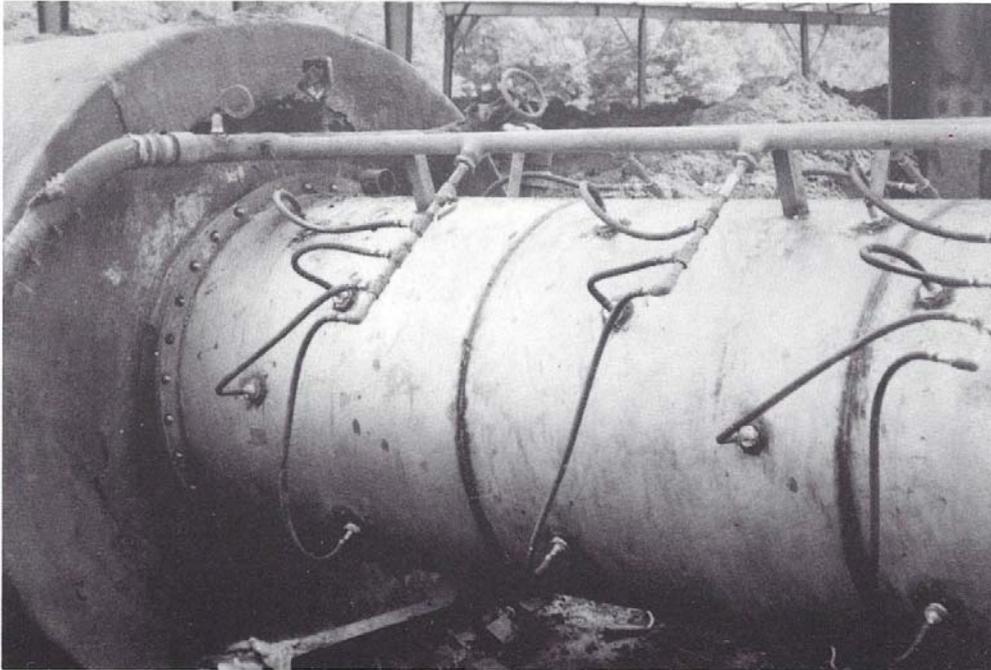
Figure 9. Pre-cooler Unit of HASTELLOY Alloy G-30 to Handle Corrosive Kiln Off Gases and Sulfuric Acid Condensates (courtesy of Eden Machine & Design Company, Eden, North Carolina).

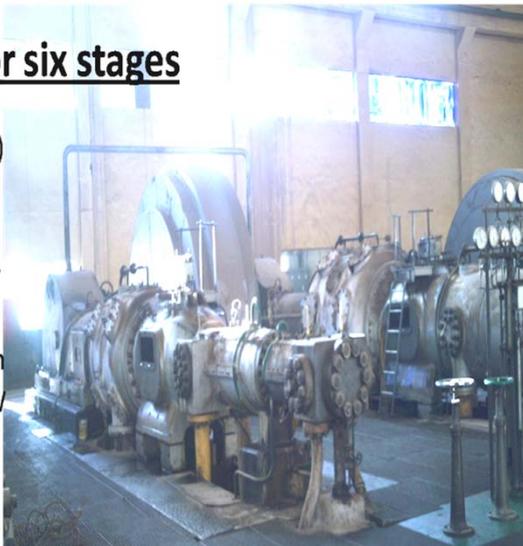
DEMAG compressor six stages

Medium: Synthesis gas (N+3H₂)
Suction pressure : 1.02 ata
Suction temperature: 45 ° C
Capacity: 13150 m³/hr
Discharge pressure: 341 ata
Speed 125 rpm
Power 4300 KW

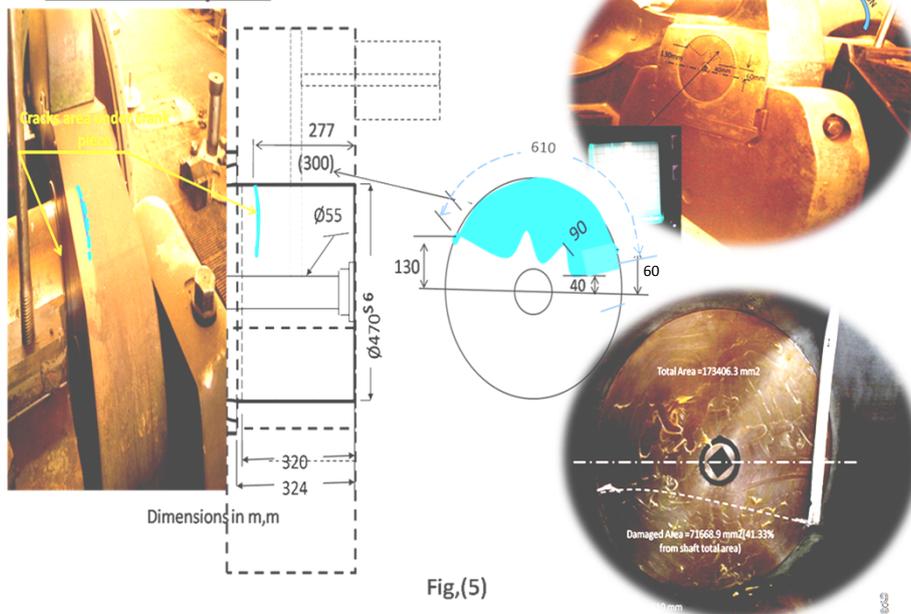
Fig,(5)

Crack description
