LESSON LEARN FROM FAILURES: FAILURE OF MIXED FEED COIL IN PRIMARY REFORMER

Nov. 2015

By: Saad Mohammed Al-Qahtani

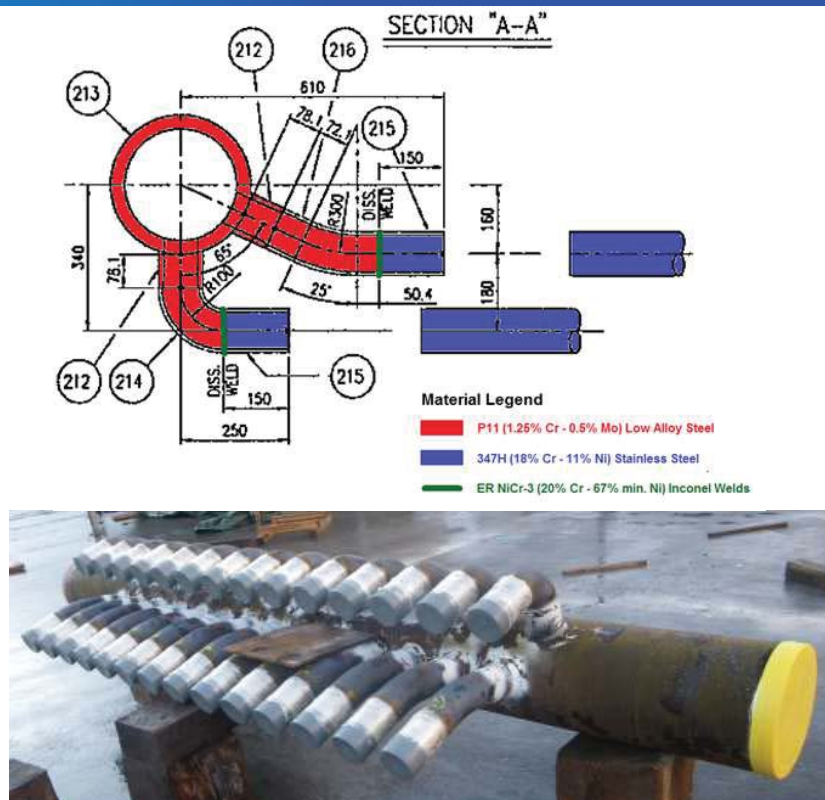
MIX FEED COIL TECHNICAL DETAILS

#	Parameter	Detail
1	Rows x Coils/Row	2 x 28
2	Coil Material of Construction	A213 TP347H
3	Header Material of Construction (In/Out)	A335 P11
4	Operating Pressure, BarG	33.6
5	Operating Temperature, °C (In/Out)	341.3/495
